DROMGOOLE HOUSE HISTORIC STRUCTURE REPORT

Old Brunswick Circuit Foundation
Valentines, Virginia

Report by Glavé & Holmes Architecture

March 25, 2022

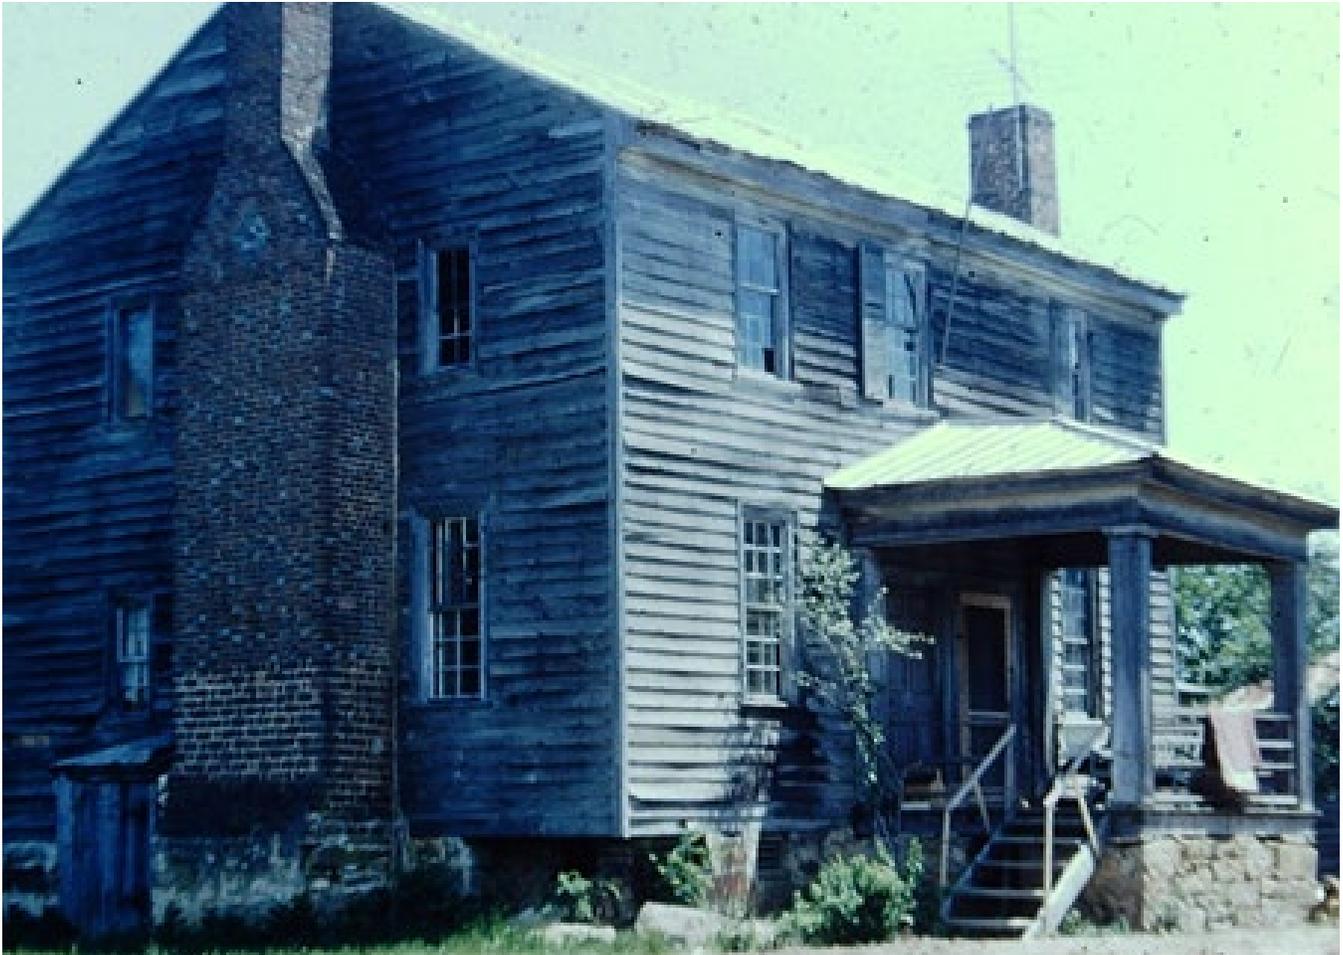
Southwest corner from southwest showing missing section of foundation, 1960s. A earlier basement entry is visible beside the chimney [Collection Old Brunswick Circuit Foundation].

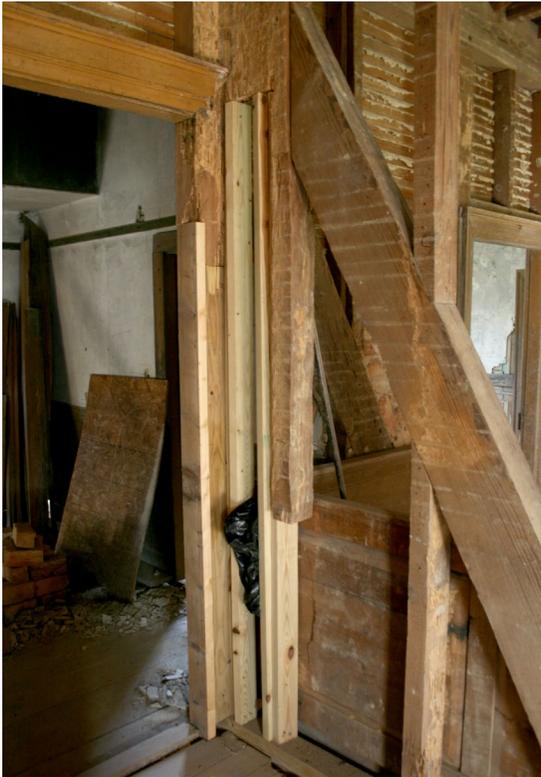
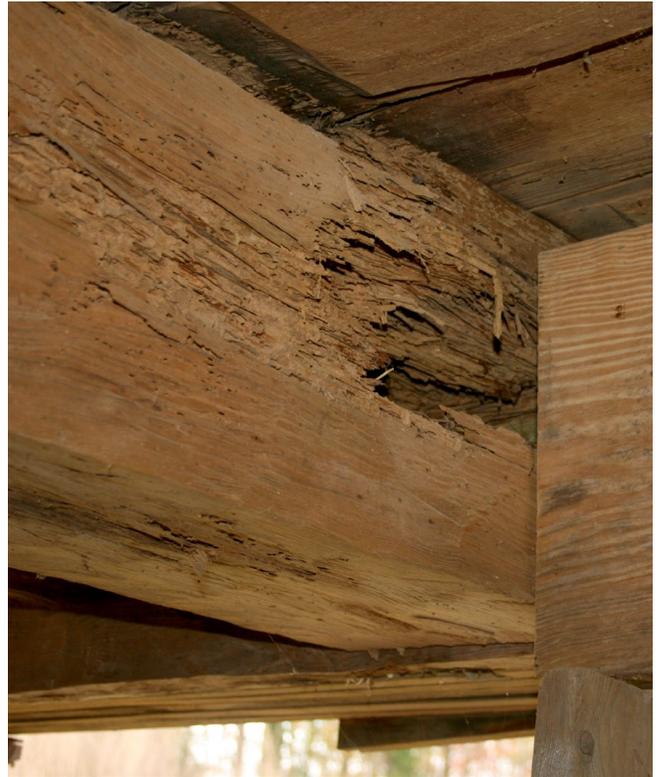
Rebuilt post at the north end of the first-floor partition between the Hall and the Parlor (left) and termite damage at the north end of a beam where it ends at the replaced sill under the north wall (right).

The frame is largely intact. There has been extensive termite damage, particularly along the north wall. The offset post at the intersection of the main dividing partitions (see above) was completely compromised, but has been reinforced with new wood. The sill under the east-west partition and some adjoining joists exhibit termite damage. The rear sill and the joists connected to it had partially collapsed into the Basement, but they have been replaced and repaired in the past decade.

- Damaged portions of the house framing should be repaired using the most sensitive techniques to avoid damaging original materials.
- Repair rather than replace wherever possible.
- Follow recommendations of structural engineer to assure the long-term safety and stability of the structure.
- Preserve the brick nogging in place to the greatest degree possible.
- There is significant deterioration of first-floor wood framing despite recent repair efforts. This will require a more comprehensive structural effort, both at the perimeter as part of an initial foundation reconstruction and at damaged locations on the interior.
- Masonry stack used for jacking appears to be crushing at base. Unclear if this element is still supporting load or was only used for jacking with load now transferred at other locations (according to Tom King, this never carried much weight).

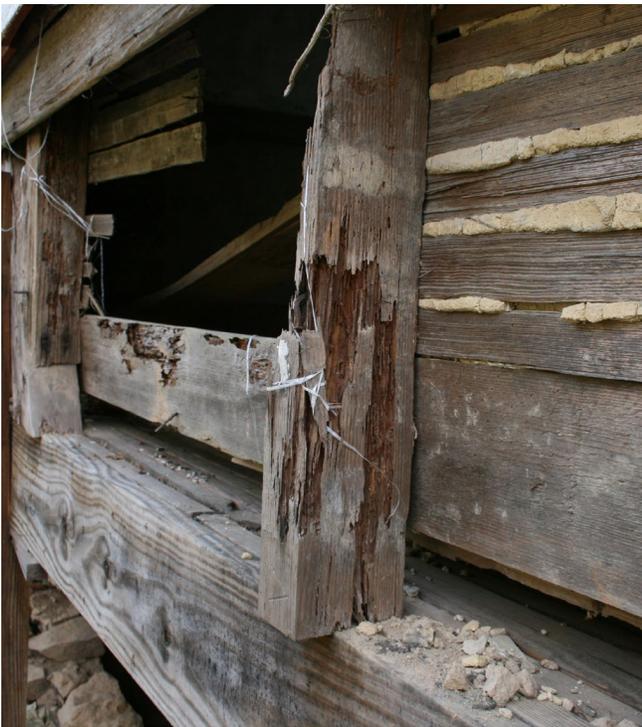
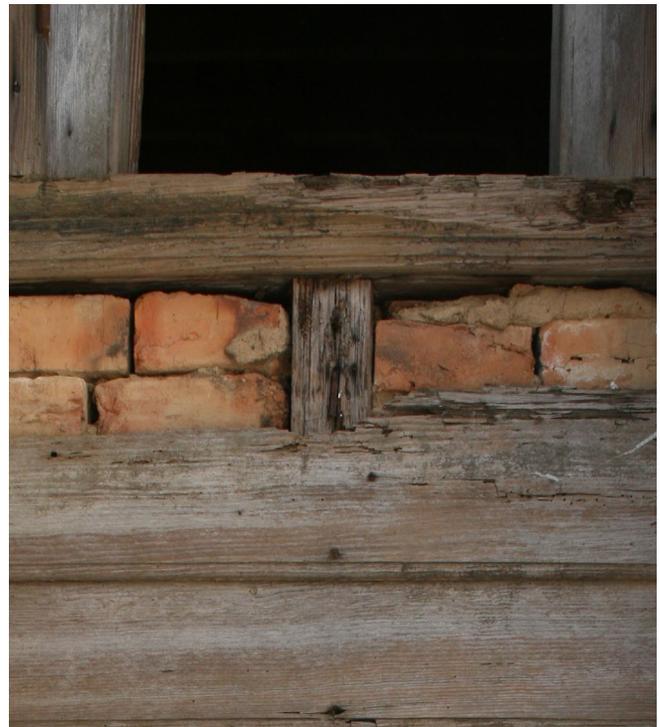
Soon after acquiring the house, the Foundation arranged for it be covered with OSB sheathing and protected from moisture by house wrap. This work was headed up by Bobby Clary using local labor in 2010. The house is still mostly obscured by the house wrap, but enough can be seen to realize that the weatherboard is in severely fragmentary and eroded condition. The window frames, sills, and trim are similarly degraded by years of neglect, but much of it is concealed by the OSB sheathing. Many window sashes are either missing or in need of repair. The cornice is missing much of the top member. Rake boards are missing. The roofing is keeping out water, but is not a long-term solution to the building's needs.

Damage to the sill on the north elevation (left) and typical brick nogging and weatherboards on the north elevation (right).

- The exterior weatherboards and trim should be repaired and replaced. Any intact sections should be maintained in situ.
- Window frames and sills should be repaired in place wherever possible.
- Window sashes should be repaired as possible or replaced with identical units.
- A new roof with adequate flashing should be installed, using either wood shingles to match physical evidence, including shingles found in the attic, or a replacement 5-V metal roof.
- Repair the porch trim, repair deteriorated portions of the porch ceiling, and replace the porch floor.
- After foundation work is complete, regrade the exterior to original levels.

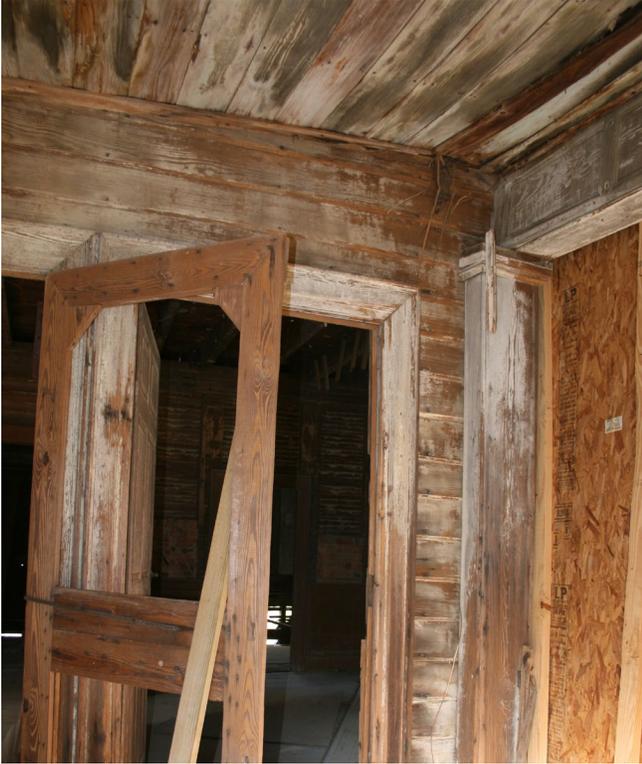
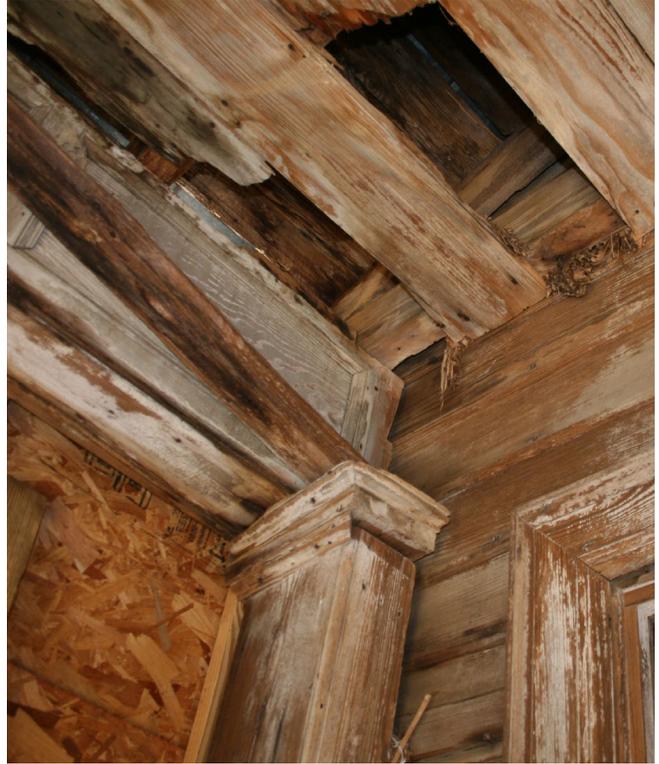
The porch needs a great deal of repair to make it safe for use by visitors. The foundation is fragmentary, the flooring is loose and unreliable, and the stairs are not usable by visitors. There are no porch railings, which is a hazard, even though the project probably doesn't need to meet code as an existing historic building. The historic photograph from 1929 on page 21 shows the porch with protective placement of two side benches to prevent people from falling off the sides of the porch.

South porch interior looking northeast (left) and south porch interior looking towards northwest towards ceiling (right).

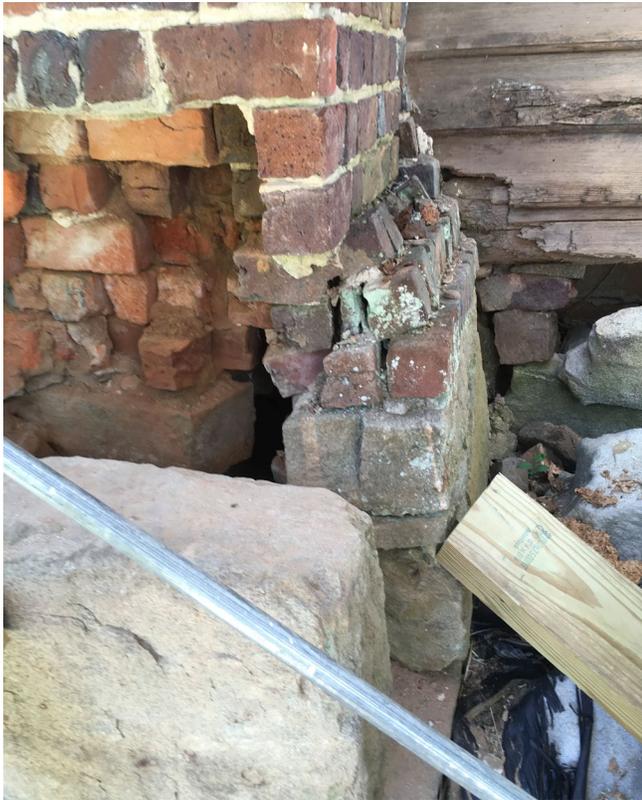
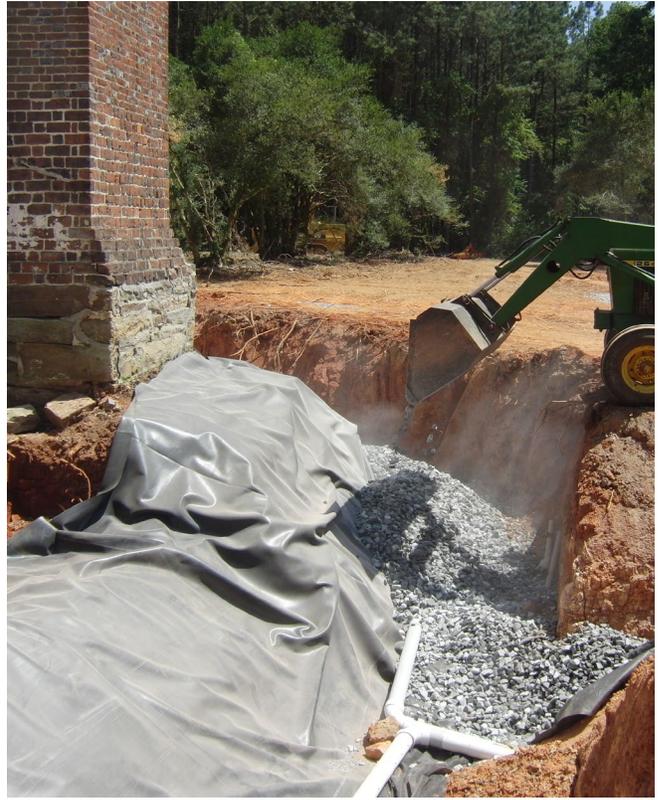
East chimney base during repair in 2013 (left) and west chimney during foundation drain installation (right).

The chimney at the east end was moving and collapsing at the base, as the outer layer of stone was forced to carry most of the weight of the brick chimney shaft above. Tom King repaired the base of the chimney and filled the void at the interior with concrete grout. The west chimney has similar problems that have not been addressed. Cracking and bulging at the base indicate that the stone outer face does not have capacity to carry the weight of the brick above. At both chimneys, the tile that originally shed water is missing from the shoulders and the upper shaft has lost integrity.

- West Chimney
 - * Rebuild from shoulder up (cracks and outward shift/lean). Document and salvage the decorative diapering pattern and put back to match existing.

- * Base appears to have been an outer wythe of mortared masonry with inner rubble fill which has become loose. Rebuild base in sections with clay bricks at interior, exterior wythe of stone masonry to match original. Similar to construction of main walls. Add new concrete footing installed in segments after repairing structural crack with stainless steel helical ties.

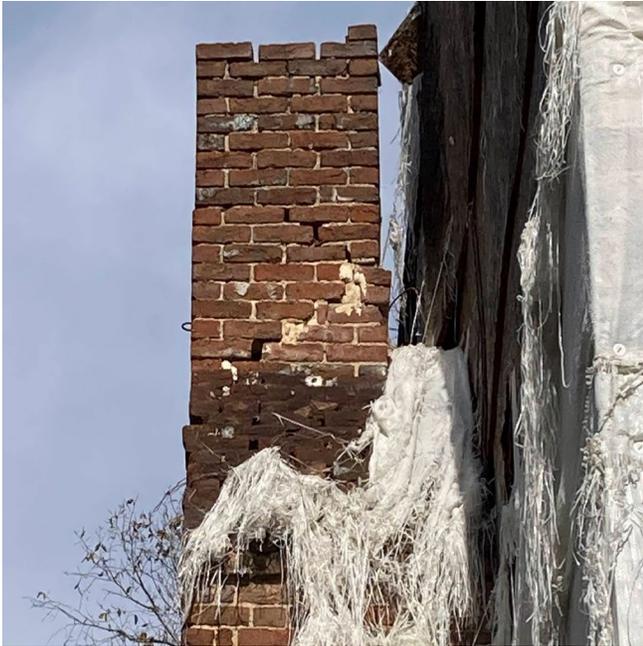
West chimney shaft looking north (left) and east chimney shaft looking north (right).

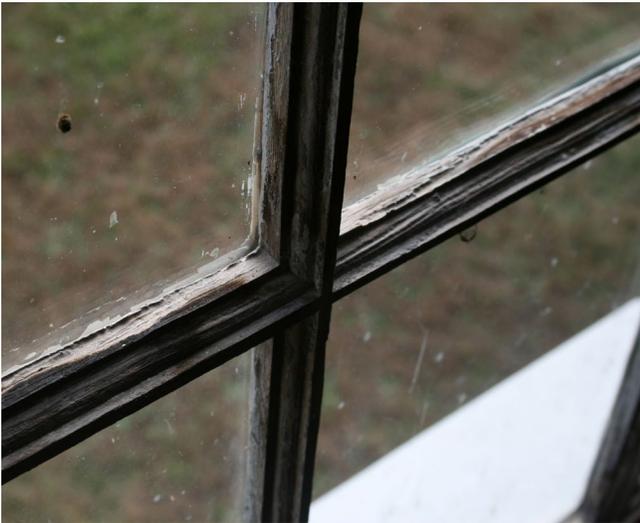
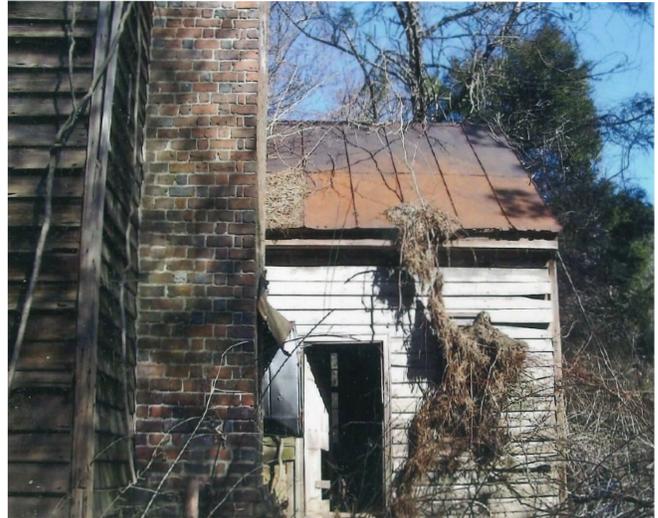
Details of the East Wing, window (left) and south front (right).

The exterior of the wing is in poor condition. Some of the weatherboards and trim elements are possibly reusable in place, particularly on the south, where they were protected for many years by the porch. The window sashes are missing. The floor framing is partially collapsed and the floor damaged. The north foundation wall is intact, although damaged by cracking. The east end and south foundation walls are in poor condition or missing entirely. The roof is sheathed with an unusual 2-V surface-nailed metal roof.

- The foundation, exterior trim, and weatherboard should be repaired or reproduced to restore the exterior to its c1810 appearance.
- Significant wood framing repairs / replacement required. Access should be closed until the flooring is sound. The floor structure should be repaired as recommended by structural engineer.

- The missing east wing chimney should probably be rebuilt, in order to make interpretive sense of the exterior of the building.
- Repair the exterior door.

- Repair surviving window sashes and reproduce missing window sashes and other elements as needed.
- Access should be provided to the door.
- Unless the porch can be shown to be an early feature of the wing, it should not be restored. This should become clear after the OSB sheathing is removed.

- Intact sections of the brick foundation (particularly under the north wall) should be repaired in place. Other damaged and missing sections of the brick foundation should be rebuilt on new footings using brick salvaged from the site.

- Underpinning of foundation is required due to deep trench adjacent (see previous discussion).
- Coordinate repair work with a new foundation for stoop or porch for access to east wing.

- Install a new wood shingle roof or a 2-V metal roof and new flashing against the two-story section.

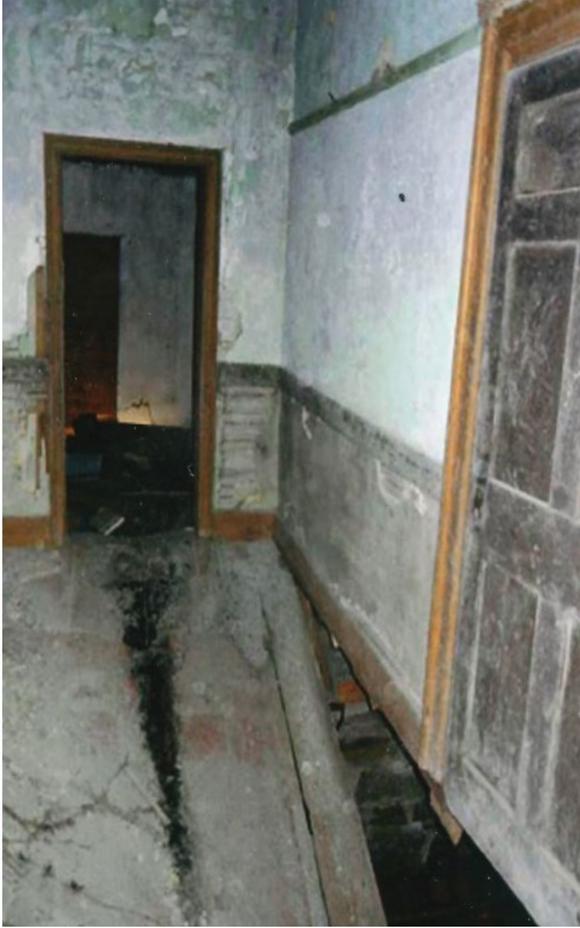
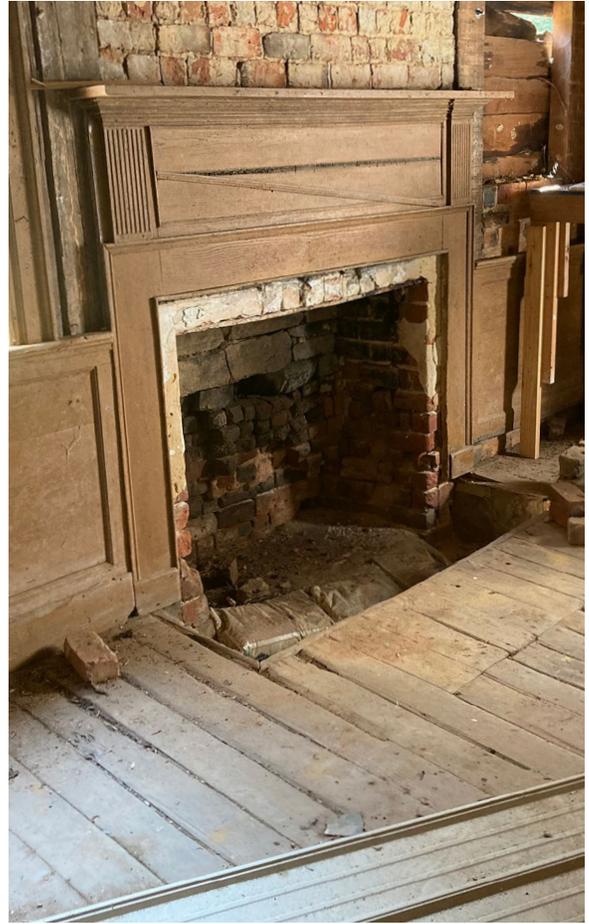
First Floor, Room 1) showing appearance before the floor was repaired c. 2013. The floor had dropped with the collapse of the rotted joists below (left). First Floor, Parlor, chimney breast showing damage to hearth, floor and fireplace interior (right).

Plaster surfaces throughout the house at the start of this project are in very poor condition. Water damage and structural deformation has resulted in the loss of extensive sections of plaster. The plaster in the two major first-floor rooms has been removed. Painted wood surfaces are badly degraded, although substantial areas of historic paint and decorative finishes, including grained surfaces, remain in place.

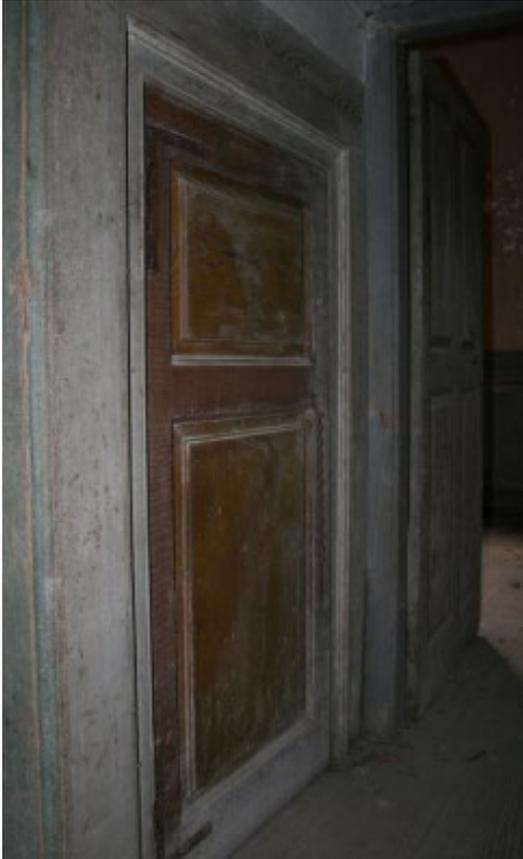
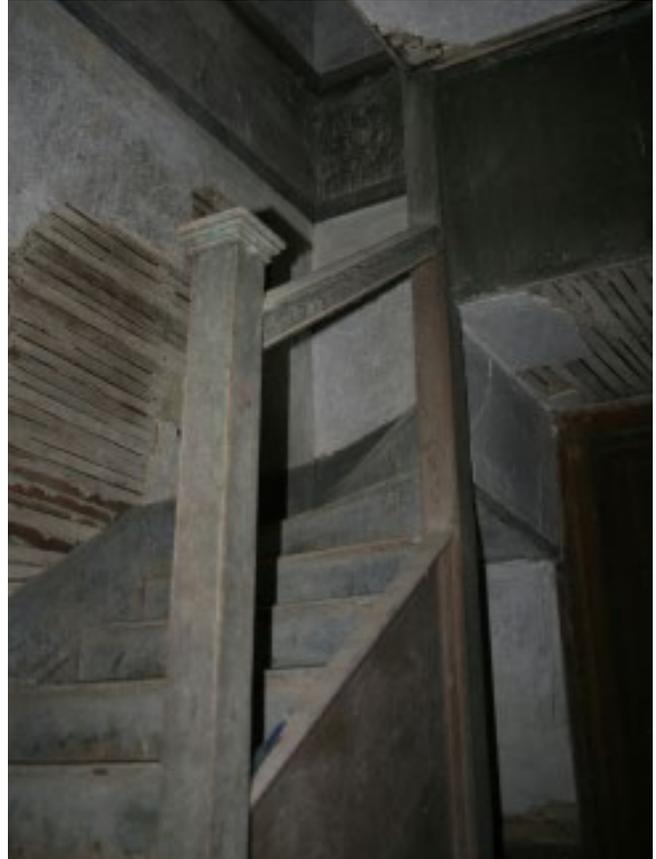
Decorative painting and graining at closet door under stair (left) and stair rail with missing balusters (right).

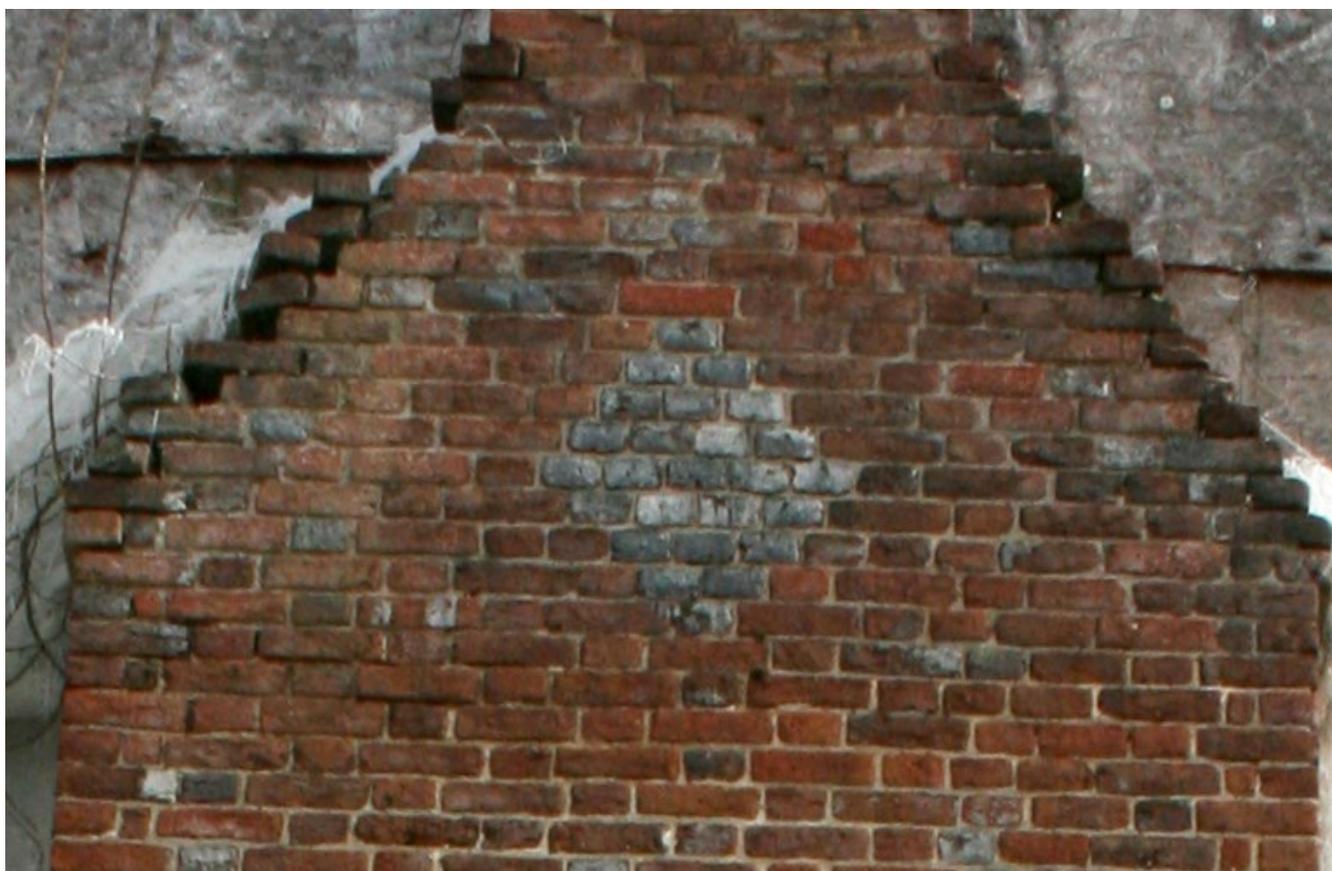
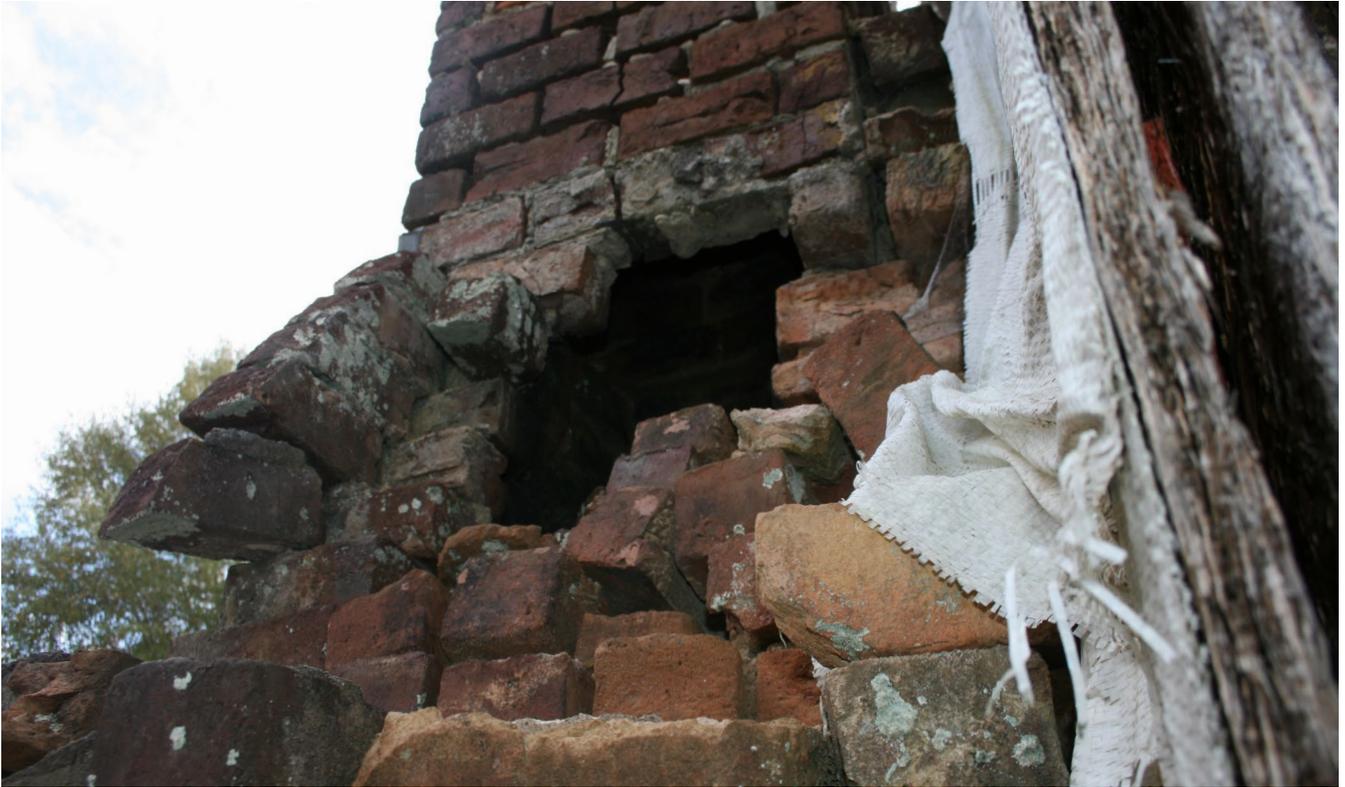
East Chimney looking south at shoulder level showing damage (above) and east chimney base looking east (below), 2021.
