DROMGOOLE HOUSE HISTORIC STRUCTURE REPORT

Old Brunswick Circuit Foundation
Valentines, Virginia

Report by Glavé & Holmes Architecture

March 25, 2022

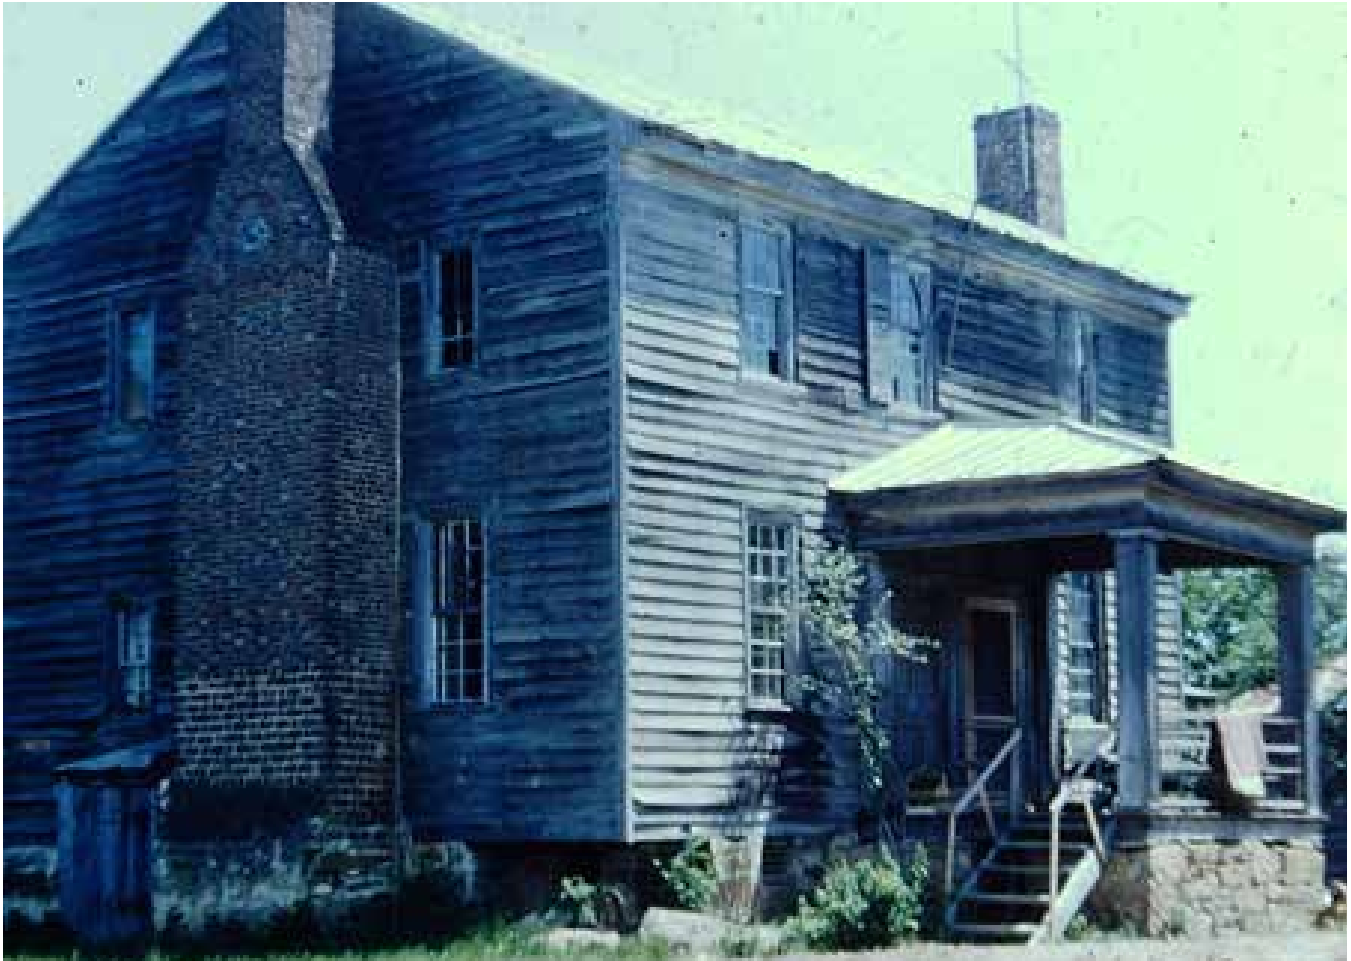
Southwest corner from southwest showing missing section of foundation, 1960s. A earlier basement entry is visible beside the chimney [Collection Old Brunswick Circuit Foundation].

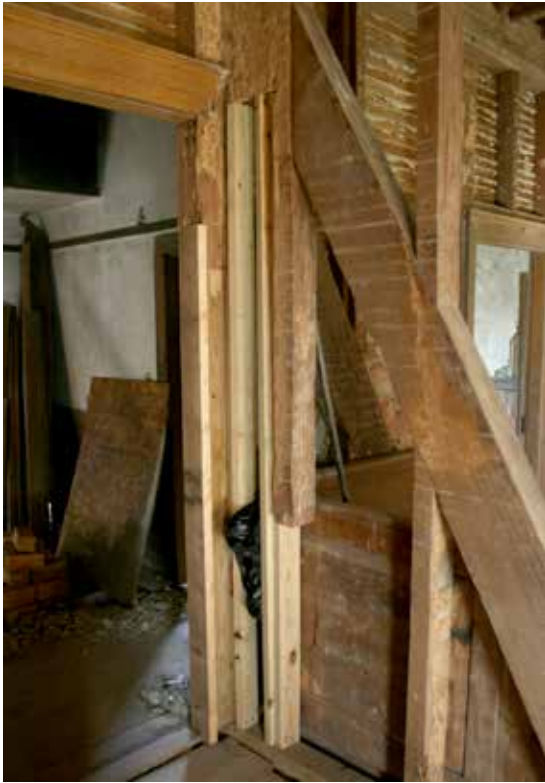
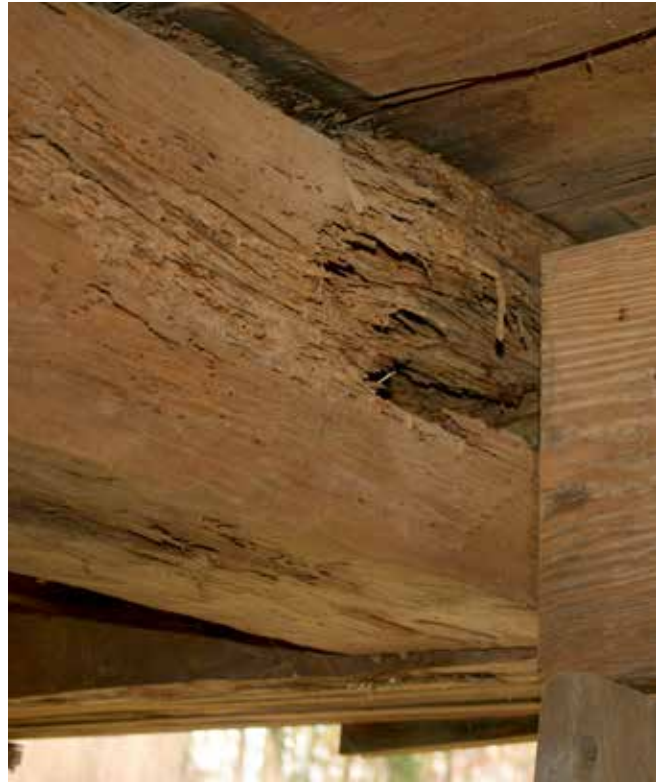
Rebuilt post at the north end of the first-floor partition between the Hall and the Parlor (left) and termite damage at the north end of a beam where it ends at the replaced sill under the north wall (right).

The frame is largely intact. There has been extensive termite damage, particularly along the north wall. The offset post at the intersection of the main dividing partitions (see above) was completely compromised, but has been reinforced with new wood. The sill under the east-west partition and some adjoining joists exhibit termite damage. The rear sill and the joists connected to it had partially collapsed into the Basement, but they have been replaced and repaired in the past decade.

- Damaged portions of the house framing should be repaired using the most sensitive techniques to avoid damaging original materials.
- Repair rather than replace wherever possible.
- Follow recommendations of structural engineer to assure the long-term safety and stability of the structure.
- Preserve the brick nogging in place to the greatest degree possible.
- There is significant deterioration of first-floor wood framing despite recent repair efforts. This will require a more comprehensive structural effort, both at the perimeter as part of an initial foundation reconstruction and at damaged locations on the interior.
- Masonry stack used for jacking appears to be crushing at base. Unclear if this element is still supporting load or was only used for jacking with load now transferred at other locations (according to Tom King, this never carried much weight).

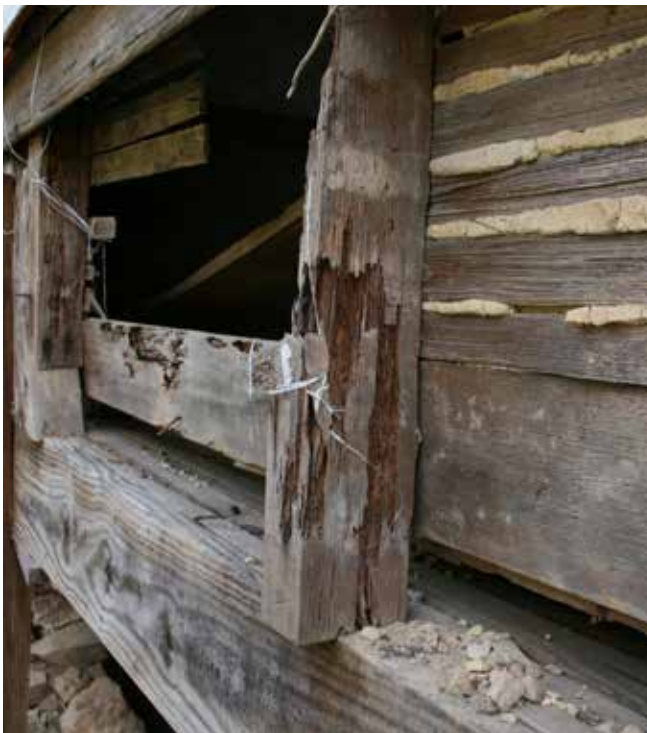
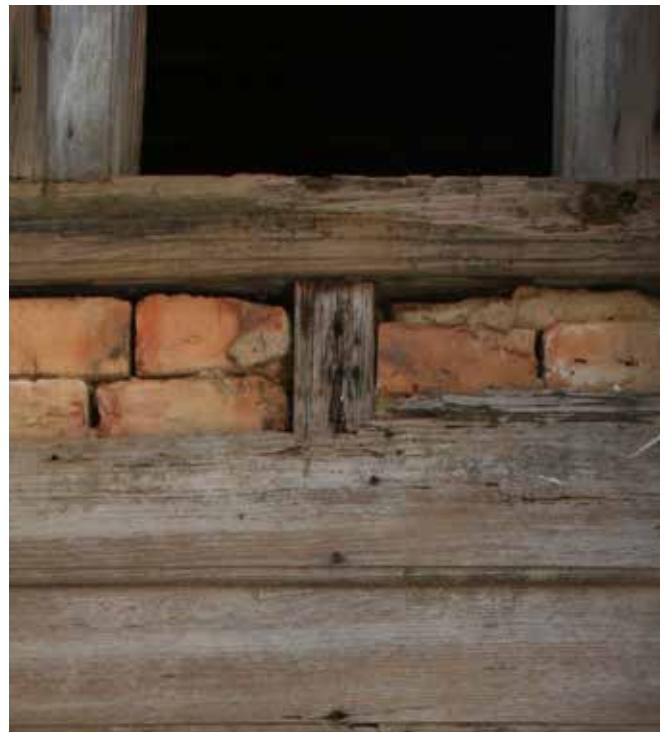
Soon after acquiring the house, the Foundation arranged for it be covered with OSB sheathing and protected from moisture by house wrap. This work was headed up by Bobby Clary using local labor in 2010. The house is still mostly obscured by the house wrap, but enough can be seen to realize that the weatherboard is in severely fragmentary and eroded condition. The window frames, sills, and trim are similarly degraded by years of neglect, but much of it is concealed by the OSB sheathing. Many window sashes are either missing or in need of repair. The cornice is missing much of the top member. Rake boards are missing. The roofing is keeping out water, but is not a long-term solution to the building's needs.

Damage to the sill on the north elevation (left) and typical brick nogging and weatherboards on the north elevation (right).

- The exterior weatherboards and trim should be repaired and replaced. Any intact sections should be maintained in situ.
- Window frames and sills should be repaired in place wherever possible.
- Window sashes should be repaired as possible or replaced with identical units.
- A new roof with adequate flashing should be installed, using either wood shingles to match physical evidence, including shingles found in the attic, or a replacement 5-V metal roof.
- Repair the porch trim, repair deteriorated portions of the porch ceiling, and replace the porch floor.
- After foundation work is complete, regrade the exterior to original levels.

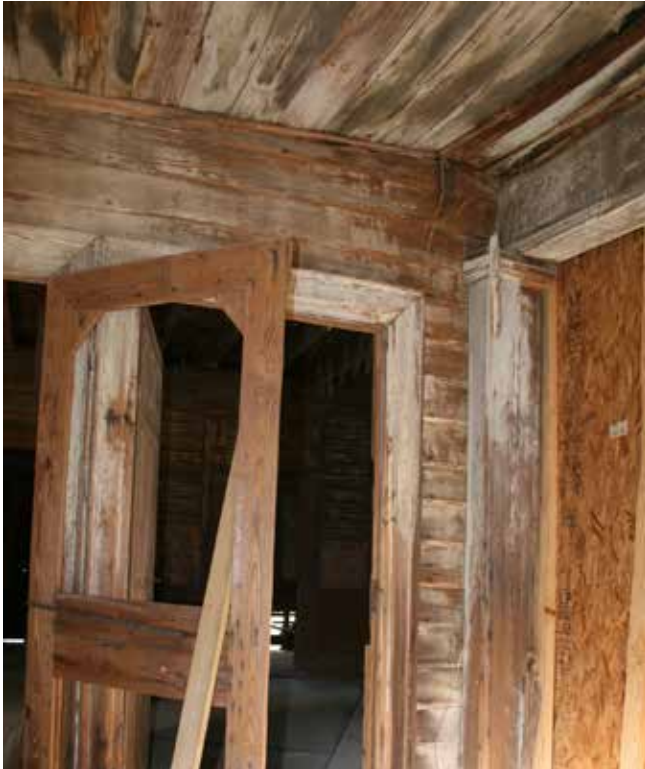
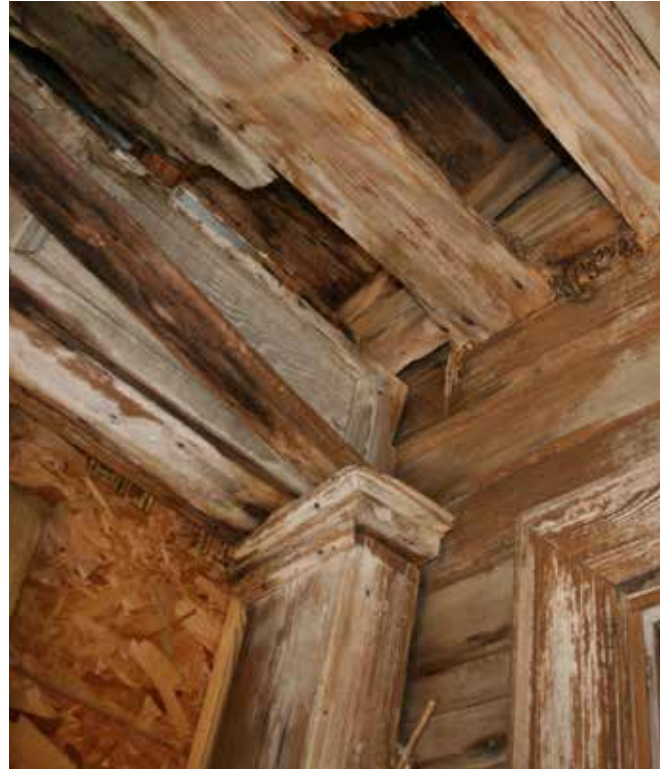
The porch needs a great deal of repair to make it safe for use by visitors. The foundation is fragmentary, the flooring is loose and unreliable, and the stairs are not usable by visitors. There are no porch railings, which is a hazard, even though the project probably doesn't need to meet code as an existing historic building. The historic photograph from 1929 on page 21 shows the porch with protective placement of two side benches to prevent people from falling off the sides of the porch.

South porch interior looking northeast (left) and south porch interior looking towards northwest towards ceiling (right).

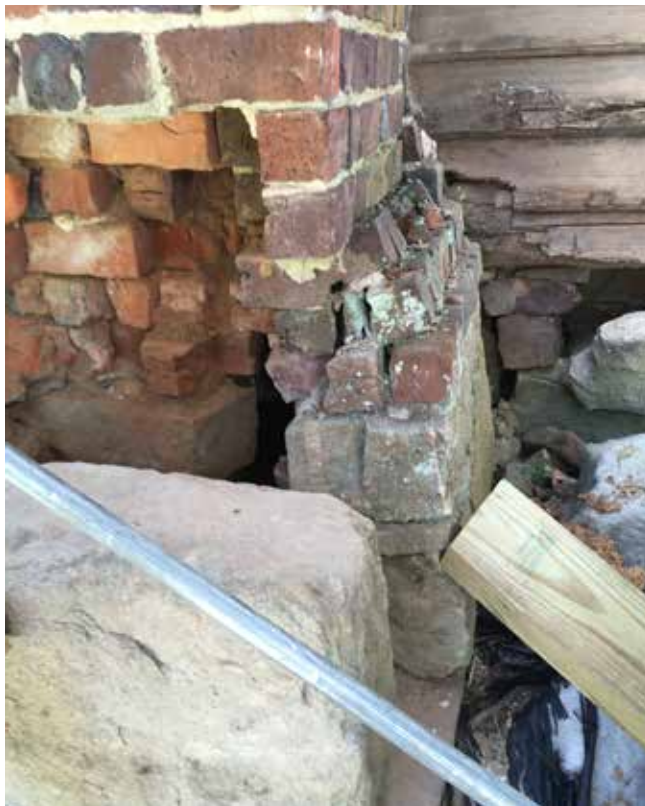
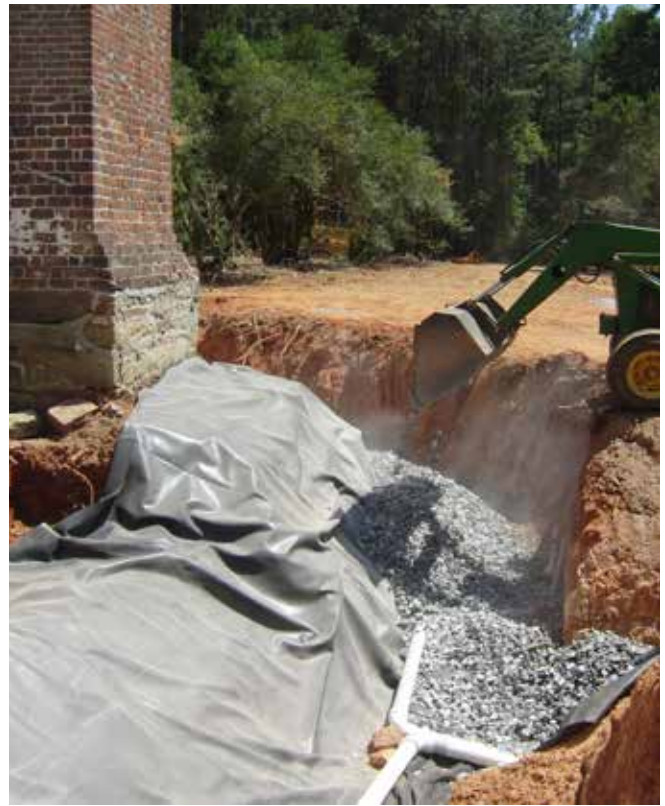
East chimney base during repair in 2013 (left) and west chimney during foundation drain installation (right).

The chimney at the east end was moving and collapsing at the base, as the outer layer of stone was forced to carry most of the weight of the brick chimney shaft above. Tom King repaired the base of the chimney and filled the void at the interior with concrete grout. The west chimney has similar problems that have not been addressed. Cracking and bulging at the base indicate that the stone outer face does not have capacity to carry the weight of the brick above. At both chimneys, the tile that originally shed water is missing from the shoulders and the upper shaft has lost integrity.

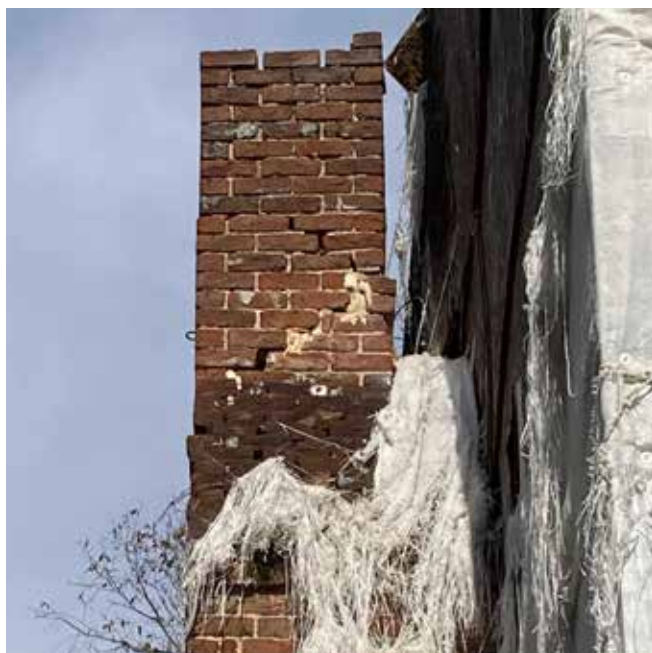
West chimney shaft looking north (left) and east chimney shaft looking north (right).

The foundation is in very poor condition. At some point after the crawl space floor was lowered, the exterior foundation wall, which was made up of an inner and outer layer separated by a rubble or mud-filled core, began to fail and was rebuilt, probably in phases over many years, as an uncoursed veneer reusing the original stones. A photograph from 1960s (page 29) shows a missing section of stone at the southwest corner before it was repaired. The only original section of properly coursed stone survives under the front porch. The rest of the foundation appears to have been rebuilt over several years using original materials. The inner layer of the foundation also failed. The inner layer of stone at the east end was rebuilt in the twentieth century, and most of the rest of the inner layer and about half of the outer layer has fallen. Thanks to local experts, the building has been shored up and the east chimney partially stabilized. The west chimney exhibits serious cracking and evidence of bulging subsidence, indicating a pressing need for stabilization and repair. The interior foundation wall at the west chimney has entirely collapsed. The building has very little lateral system at the base especially on the north side and its gravity supports are patched together. Foundation repairs should move ahead as soon as possible to minimize risk of losing the building or a more thorough and professional shoring system should be put in place.

- West Chimney
 - * Rebuild from shoulder up (cracks and outward shift/lean). Document and salvage the decorative diapering pattern and put back to match existing.

- * Base appears to have been an outer wythe of mortared masonry with inner rubble fill which has become loose. Rebuild base in sections with clay bricks at interior, exterior wythe of stone masonry to match original. Similar to construction of main walls. Add new concrete footing installed in segments after repairing structural crack with stainless steel helical ties.

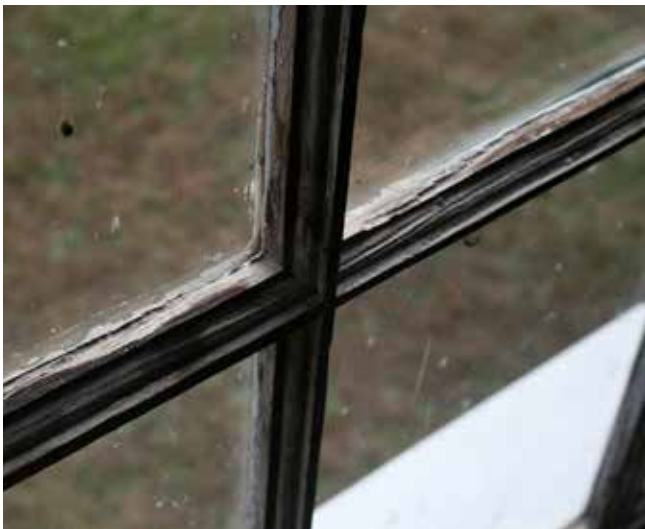
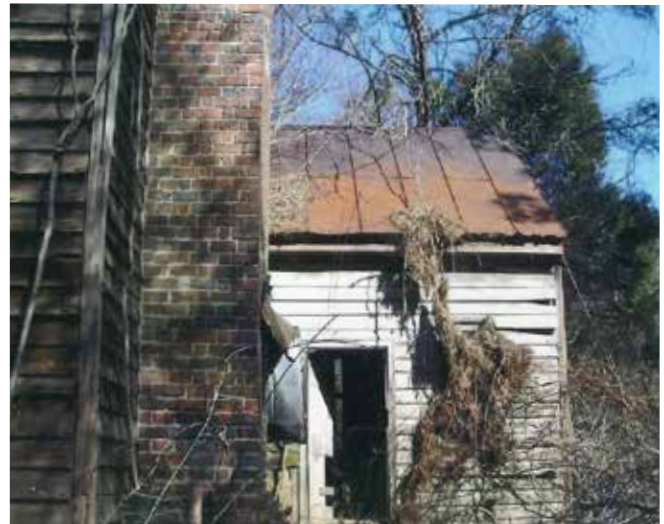
Details of the East Wing, window (left) and south front (right).

The exterior of the wing is in poor condition. Some of the weatherboards and trim elements are possibly reusable in place, particularly on the south, where they were protected for many years by the porch. The window sashes are missing. The floor framing is partially collapsed and the floor damaged. The north foundation wall is intact, although damaged by cracking. The east end and south foundation walls are in poor condition or missing entirely. The roof is sheathed with an unusual 2-V surface-nailed metal roof.

- The foundation, exterior trim, and weatherboard should be repaired or reproduced to restore the exterior to its c1810 appearance.
- Significant wood framing repairs / replacement required. Access should be closed until the flooring is sound. The floor structure should be repaired as recommended by structural engineer.

- The missing east wing chimney should probably be rebuilt, in order to make interpretive sense of the exterior of the building.
- Repair the exterior door.

- Repair surviving window sashes and reproduce missing window sashes and other elements as needed.
- Access should be provided to the door.
- Unless the porch can be shown to be an early feature of the wing, it should not be restored. This should become clear after the OSB sheathing is removed.

- Intact sections of the brick foundation (particularly under the north wall) should be repaired in place. Other damaged and missing sections of the brick foundation should be rebuilt on new footings using brick salvaged from the site.

- Underpinning of foundation is required due to deep trench adjacent (see previous discussion).
- Coordinate repair work with a new foundation for stoop or porch for access to east wing.

- Install a new wood shingle roof or a 2-V metal roof and new flashing against the two-story section.

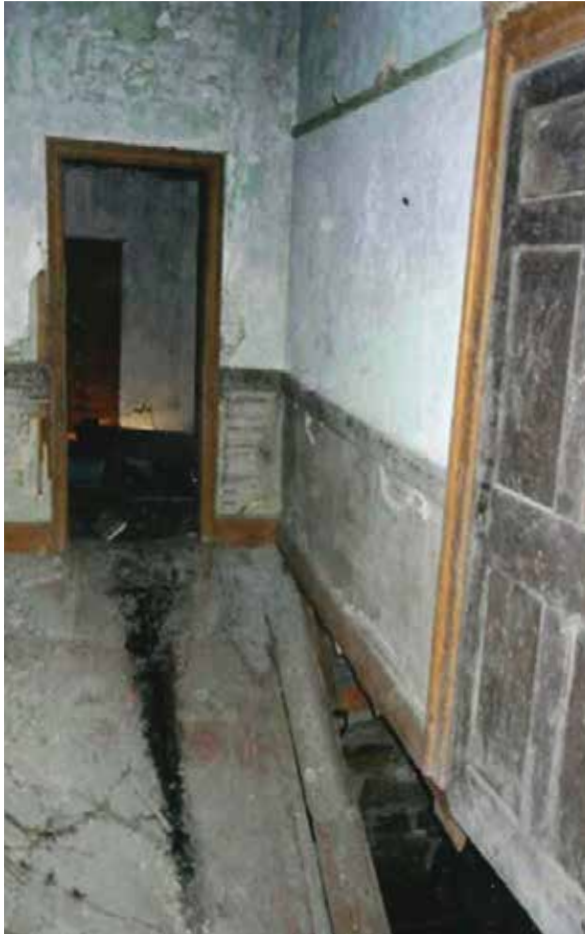
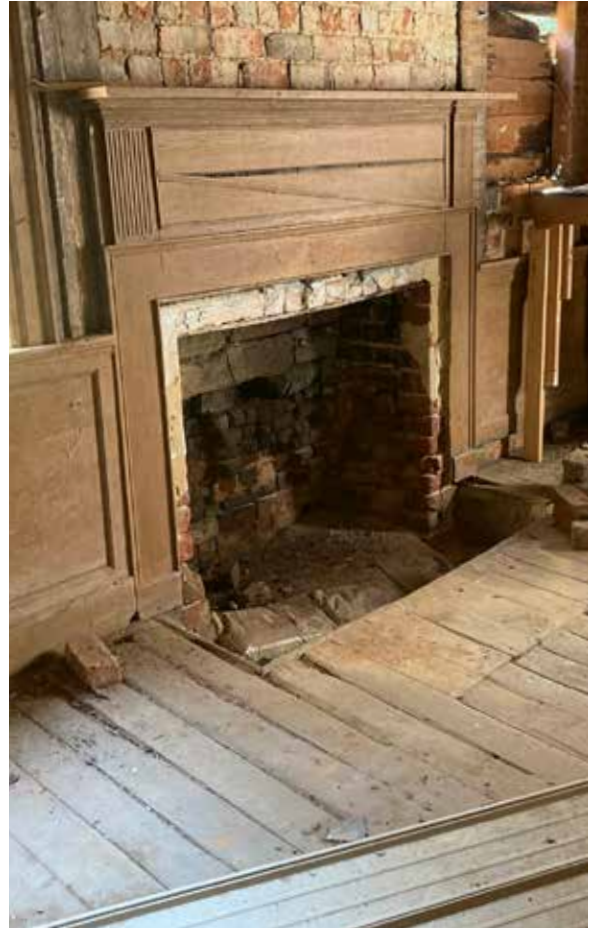
First Floor, Room 1) showing appearance before the floor was repaired c. 2013. The floor had dropped with the collapse of the rotted joists below (left). First Floor, Parlor, chimney breast showing damage to hearth, floor and fireplace interior (right).

Plaster surfaces throughout the house at the start of this project are in very poor condition. Water damage and structural deformation has resulted in the loss of extensive sections of plaster. The plaster in the two major first-floor rooms has been removed. Painted wood surfaces are badly degraded, although substantial areas of historic paint and decorative finishes, including grained surfaces, remain in place.

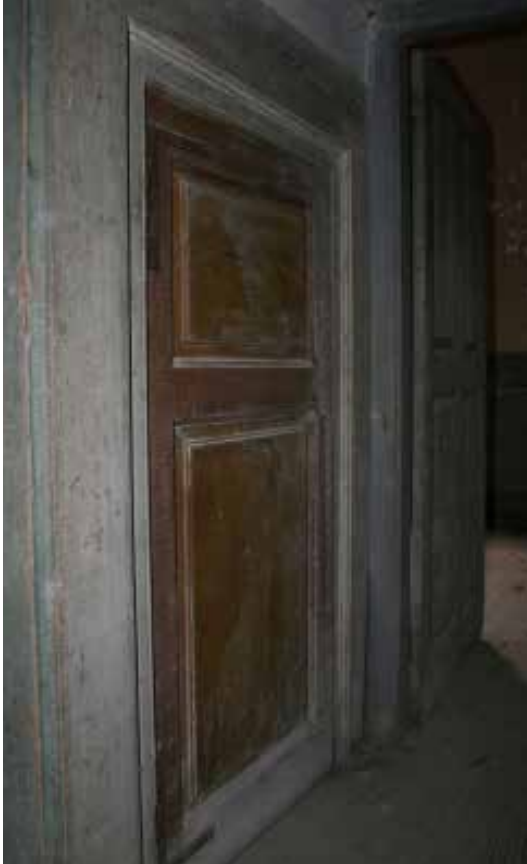
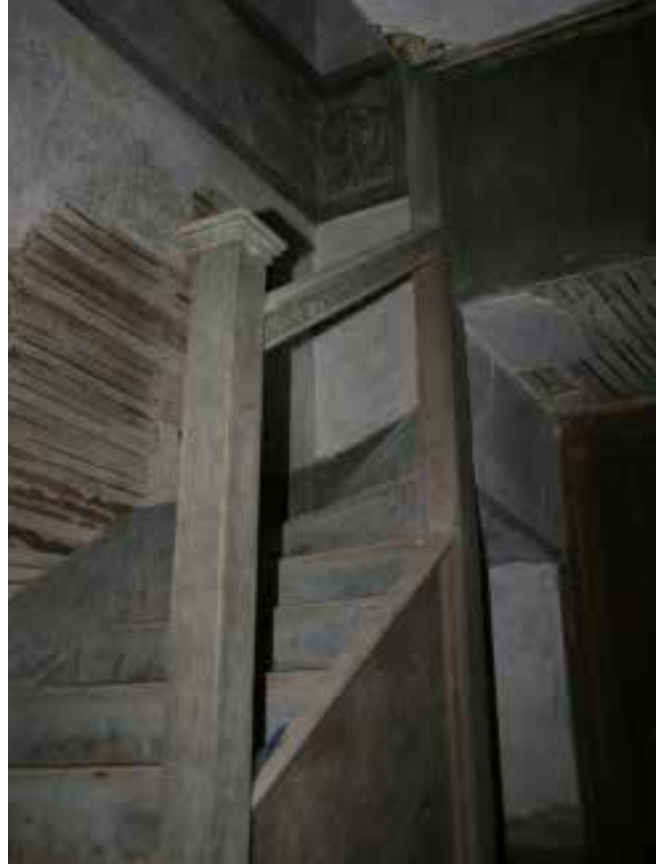
Decorative painting and graining at closet door under stair (left) and stair rail with missing balusters (right).

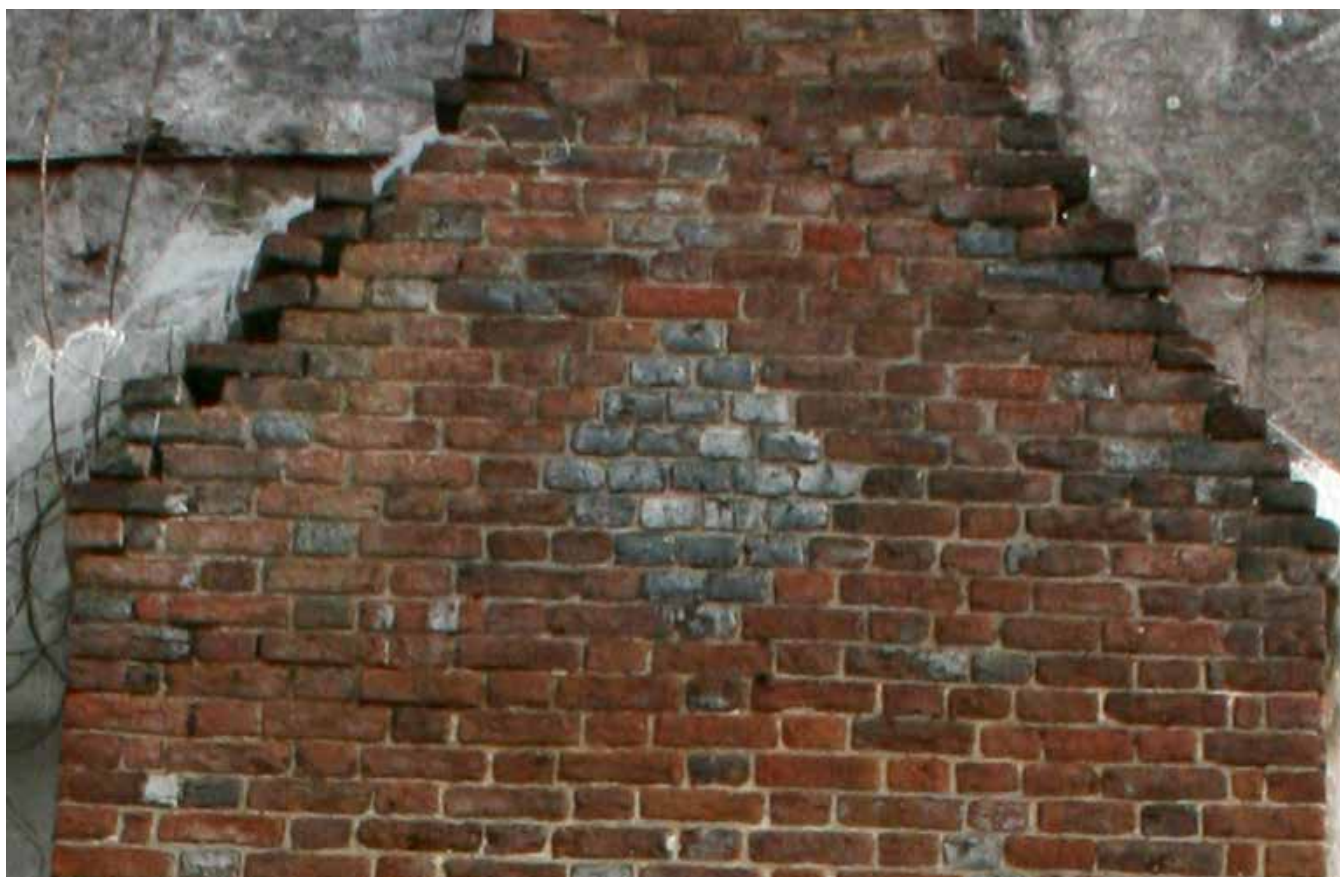
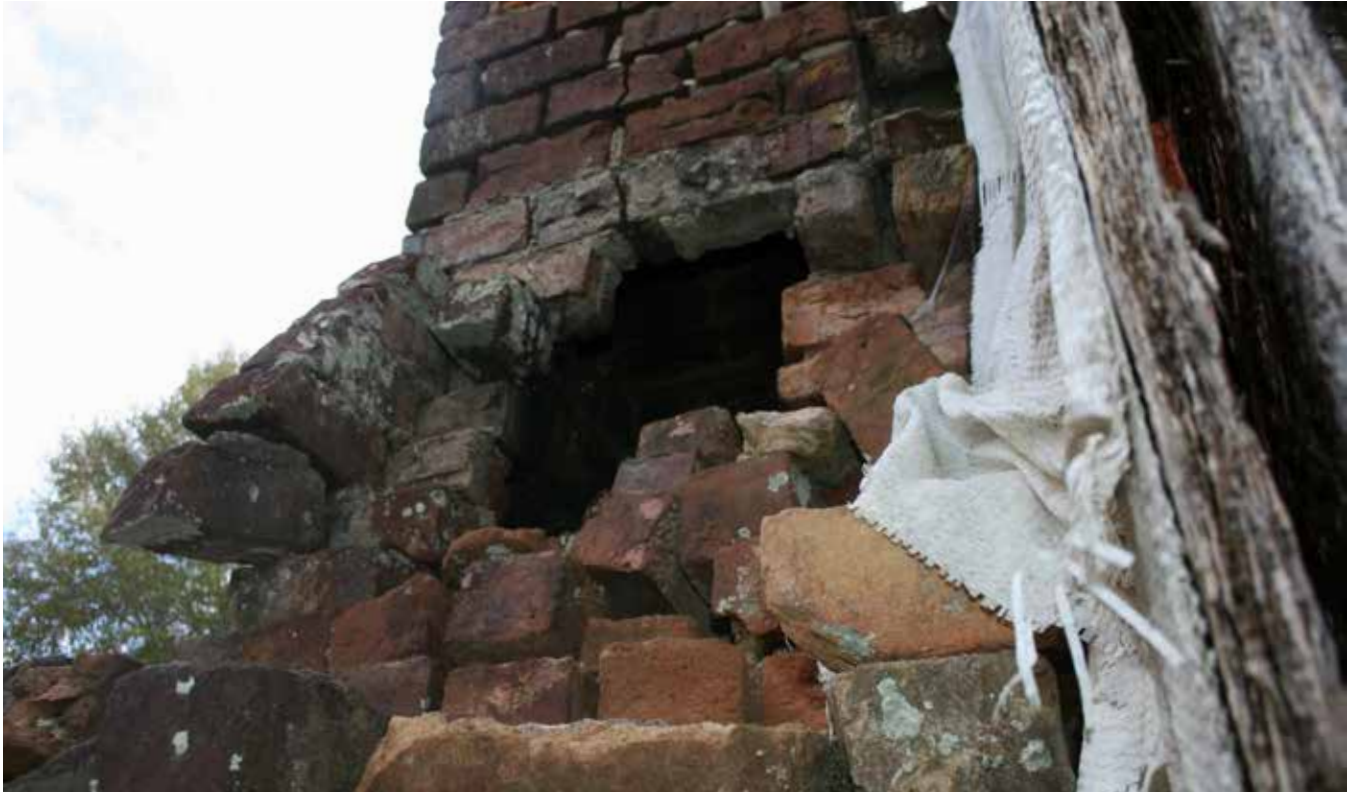
East Chimney looking south at shoulder level showing damage (above) and east chimney base looking east (below), 2021.
