DROMGOOLE HOUSE HISTORIC STRUCTURE REPORT

Old Brunswick Circuit Foundation
Valentines, Virginia

Report by Glavé & Holmes Architecture

March 25, 2022

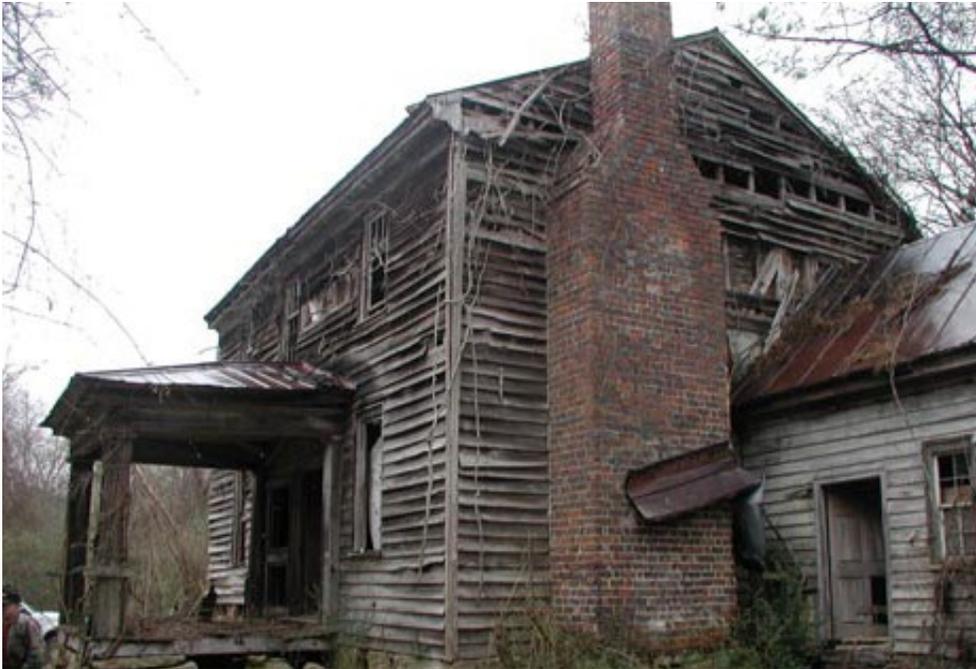
Dromgoole House at Canaan, view from the southeast, 2006. A portion of the former porch roof of the east wing porch is visible attached to the chimney.

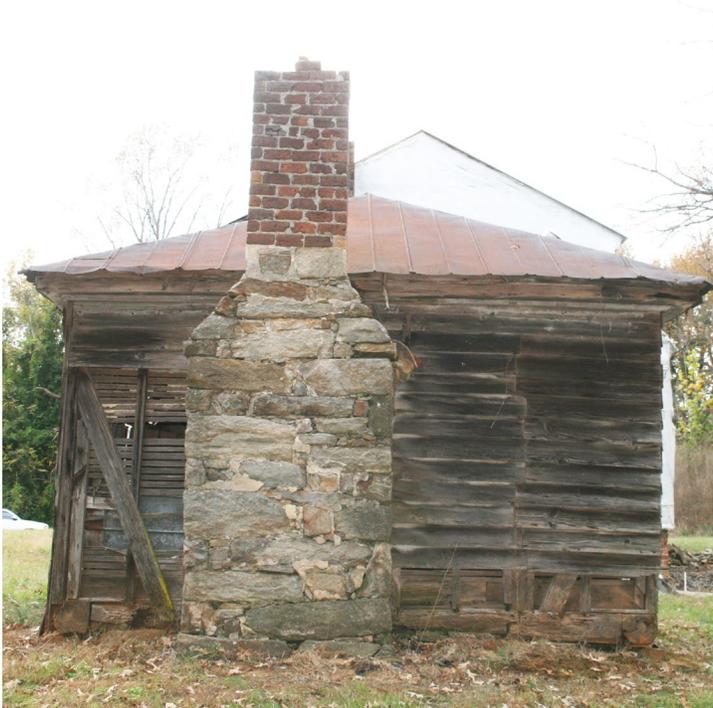
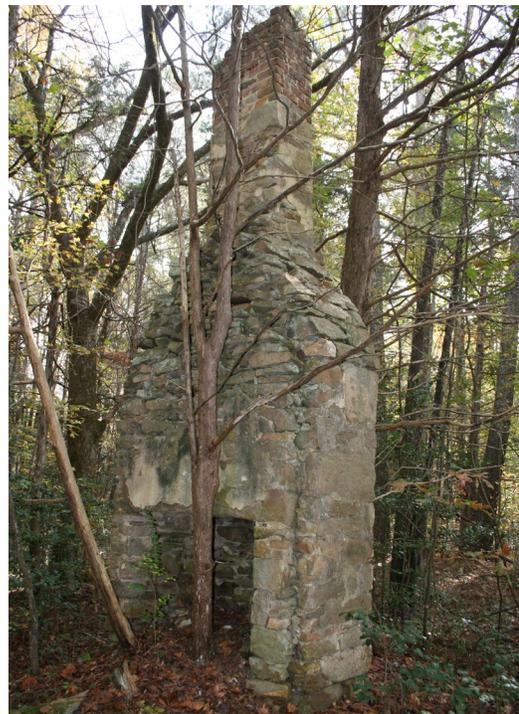
Kitchen, known today as the "Weaving House" or "Spinning House" from the east (left). Note the cut in siding, chimney posts and down braces indicating the location of larger original chimney. Stone chimney at secondary house site to east of the main house seen from northwest (right).

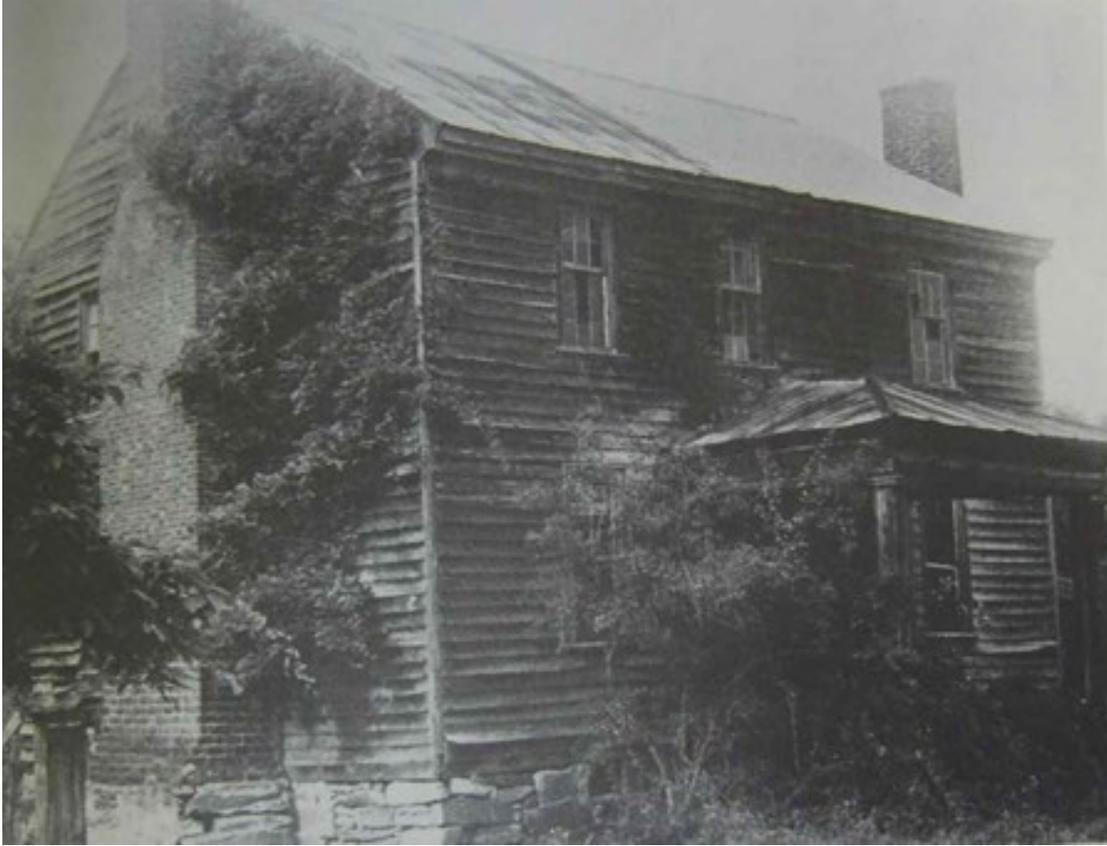
Southwest corner from the southwest showing repaired foundation, 1970s [Corker, Collection Old Brunswick Circuit Foundation].

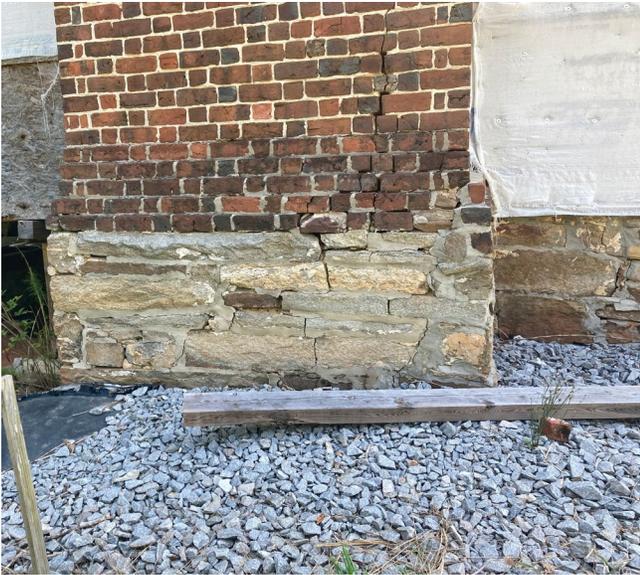
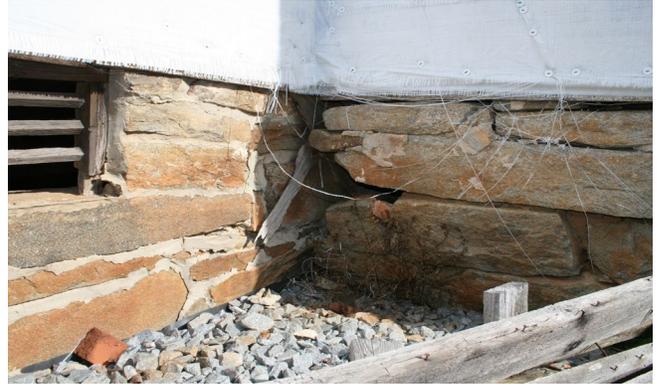
Dromgoole House, west chimney base (left) and western angle of front porch (right).

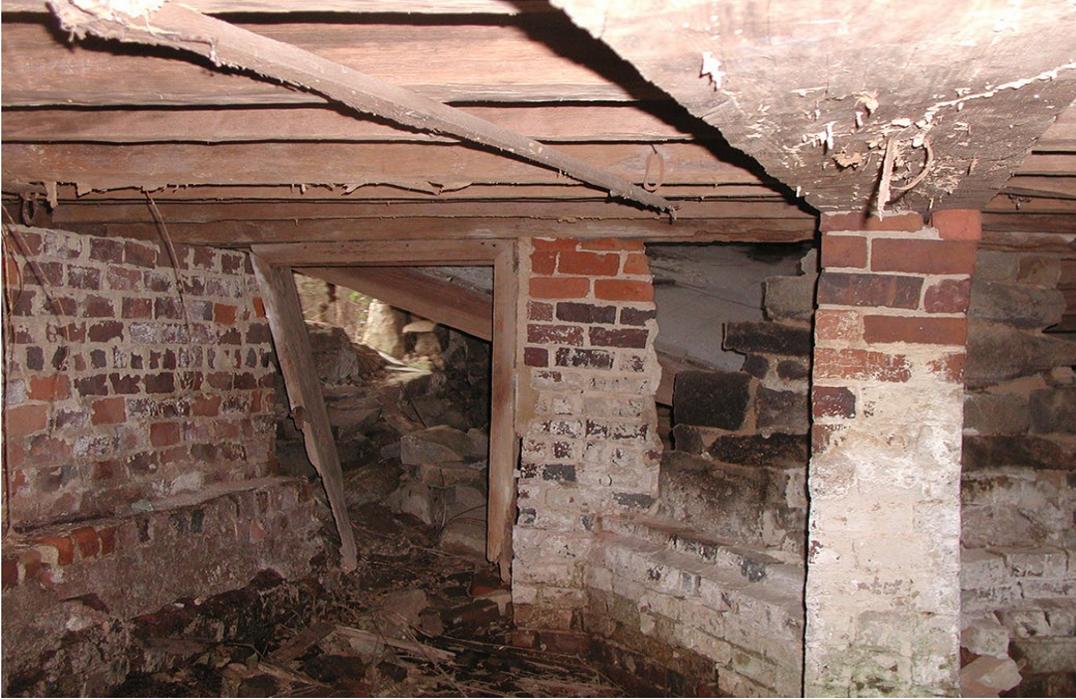
Basement- view of the north half of the Basement looking east showing the diagonal pier and added brick partition to the right. The door frame, no longer in place after the repairs of 2013, connected the room on the east side of the Basement with the room(s) on the west.

- Provide a crawl space entry to the north side of the west chimney. Recreate the likely form of a historic basement bulkhead at that location.
- The section of brick cross wall on the interior should be preserved in place and the Basement filled with gravel to the level of the original crawl space.

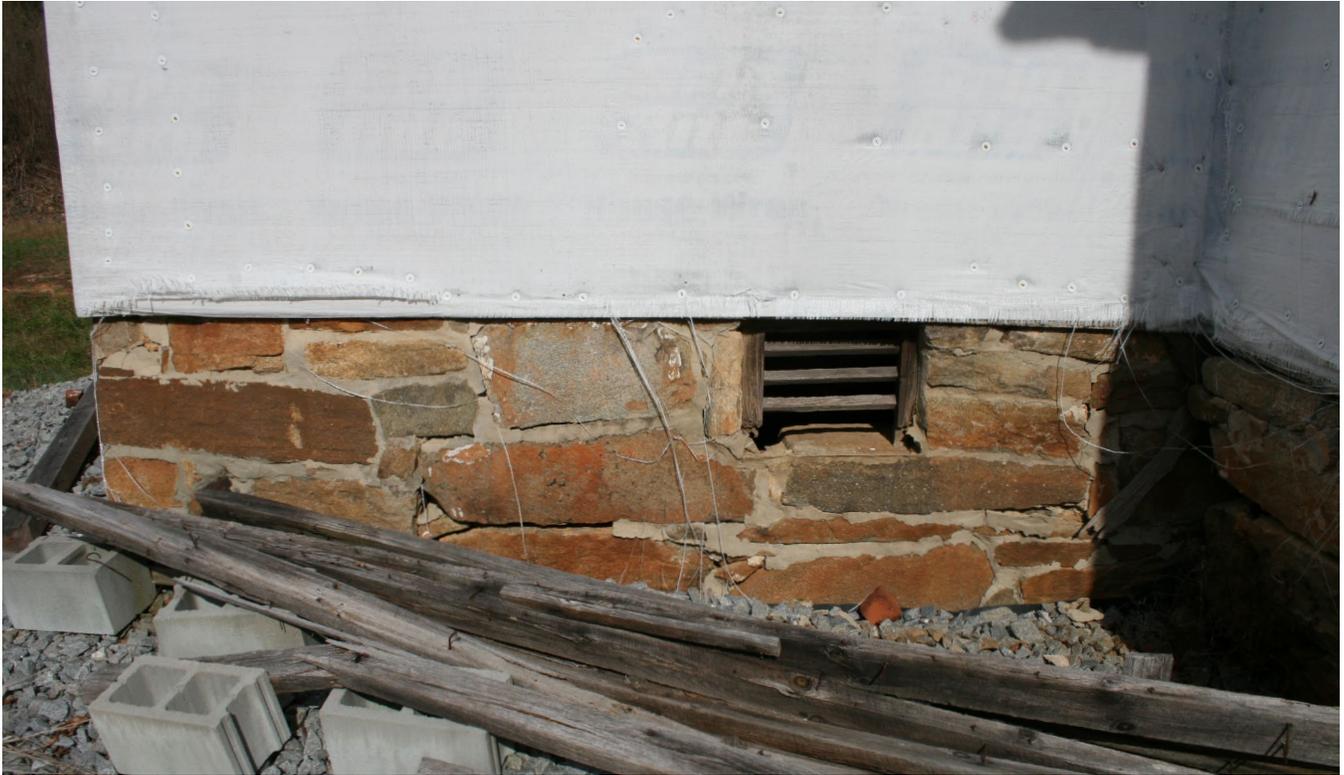
The foundation is in very poor condition. At some point after the crawl space floor was lowered, the exterior foundation wall, which was made up of an inner and outer layer separated by a rubble or mud-filled core, began to fail and was rebuilt, probably in phases over many years, as an uncoursed veneer reusing the original stones. A photograph from 1960s (page 29) shows a missing section of stone at the southwest corner before it was repaired. The only original section of properly coursed stone survives under the front porch. The rest of the foundation appears to have been rebuilt over several years using original materials. The inner layer of the foundation also failed. The inner layer of stone at the east end was rebuilt in the twentieth century, and most of the rest of the inner layer and about half of the outer layer has fallen. Thanks to local experts, the building has been shored up and the east chimney partially stabilized. The west chimney exhibits serious cracking and evidence of bulging subsidence, indicating a pressing need for stabilization and repair. The interior foundation wall at the west chimney has entirely collapsed. The building has very little lateral system at the base especially on the north side and its gravity supports are patched together. Foundation repairs should move ahead as soon as possible to minimize risk of losing the building or a more thorough and professional shoring system should be put in place.

Foundation, west end, south elevation (above) and west end of porch (below), 2021.

- Remove and rebuild the entire foundation, except for intact portions of the south porch foundation and the central section of the south wall under the south porch, which appear to be structurally competent.

- Sections of foundation should be underpinned, repaired, and repointed using appropriately formulated lime-based mortar to permit moisture movement and evaporation.

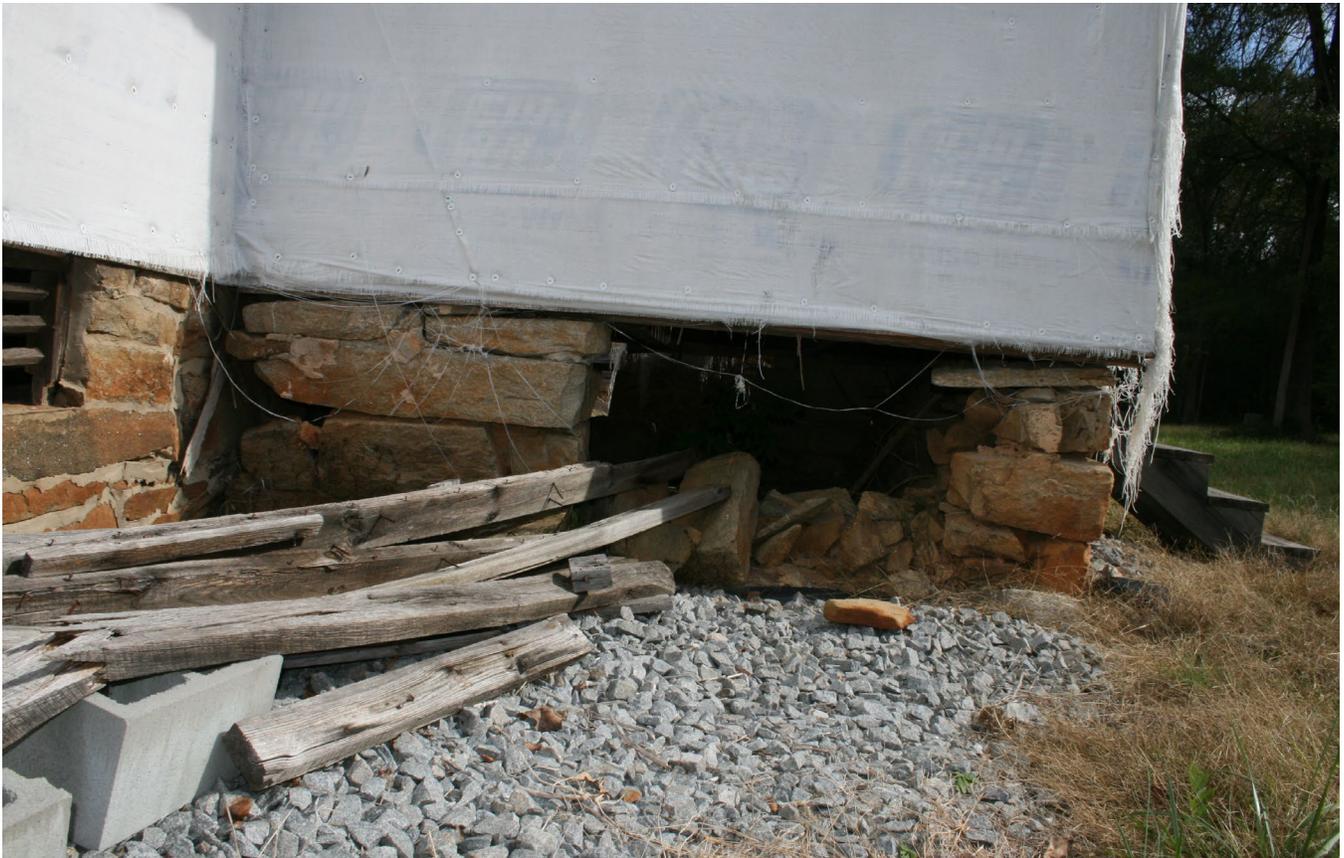
The chimney at the east end was moving and collapsing at the base, as the outer layer of stone was forced to carry most of the weight of the brick chimney shaft above. Tom King repaired the base of the chimney and filled the void at the interior with concrete grout. The west chimney has similar problems that have not been addressed. Cracking and bulging at the base indicate that the stone outer face does not have capacity to carry the weight of the brick above. At both chimneys, the tile that originally shed water is missing from the shoulders and the upper shaft has lost integrity.

Base of east chimney (above) and East Wing foundation from the southeast (below), 2021.

- * Previous repairs have poured concrete into interior to tie together. While not ideal as far as reversibility, this may have been determined necessary in earlier years to stabilize the brick above. Now that it is presumed to be solidly adhered with the concrete, consider underpinning to mitigate future movement.

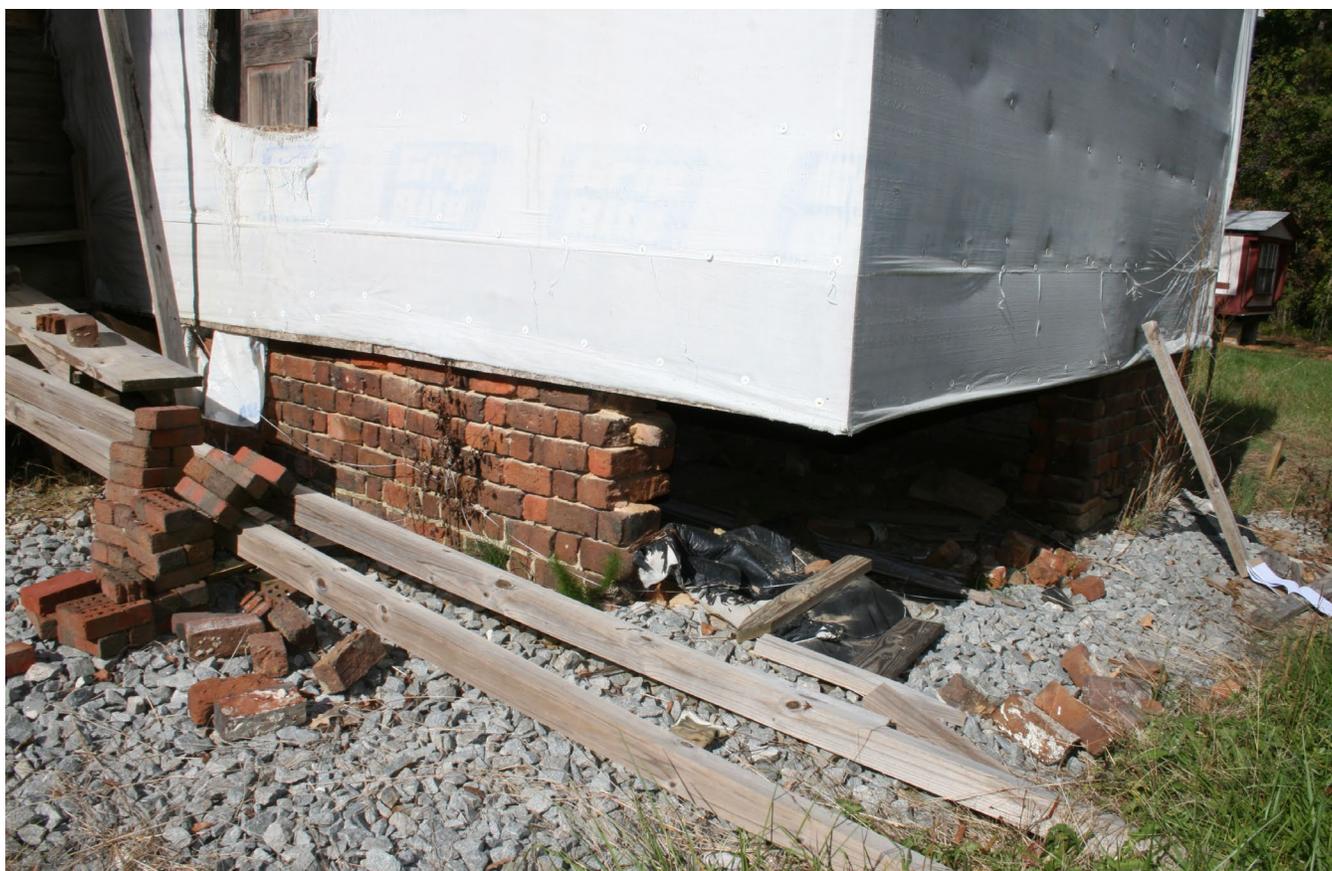
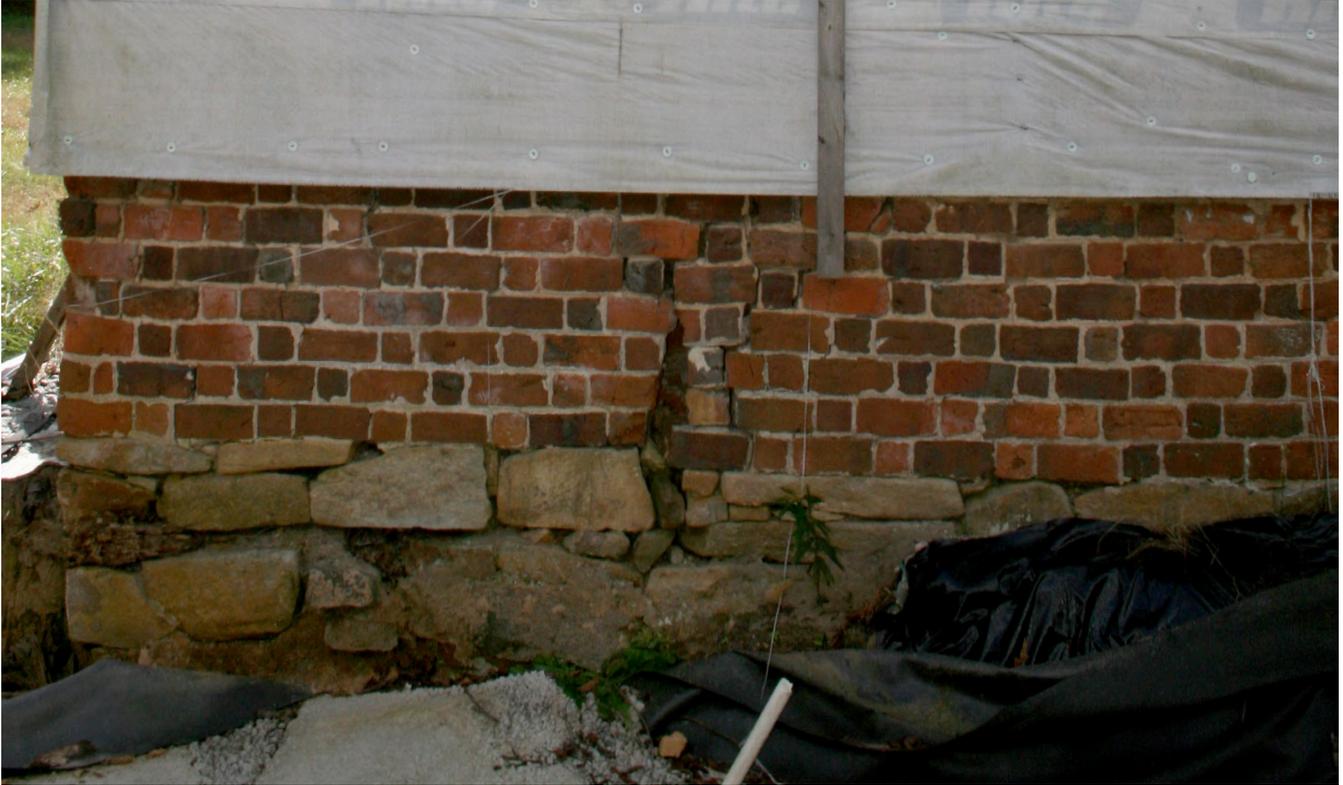
The exterior of the wing is in poor condition. Some of the weatherboards and trim elements are possibly reusable in place, particularly on the south, where they were protected for many years by the porch. The window sashes are missing. The floor framing is partially collapsed and the floor damaged. The north foundation wall is intact, although damaged by cracking. The east end and south foundation walls are in poor condition or missing entirely. The roof is sheathed with an unusual 2-V surface-nailed metal roof.

Foundation, north elevation, East Wing (above) and junction between East wing and main house foundation (below), 2021.

- Intact sections of the brick foundation (particularly under the north wall) should be repaired in place. Other damaged and missing sections of the brick foundation should be rebuilt on new footings using brick salvaged from the site.

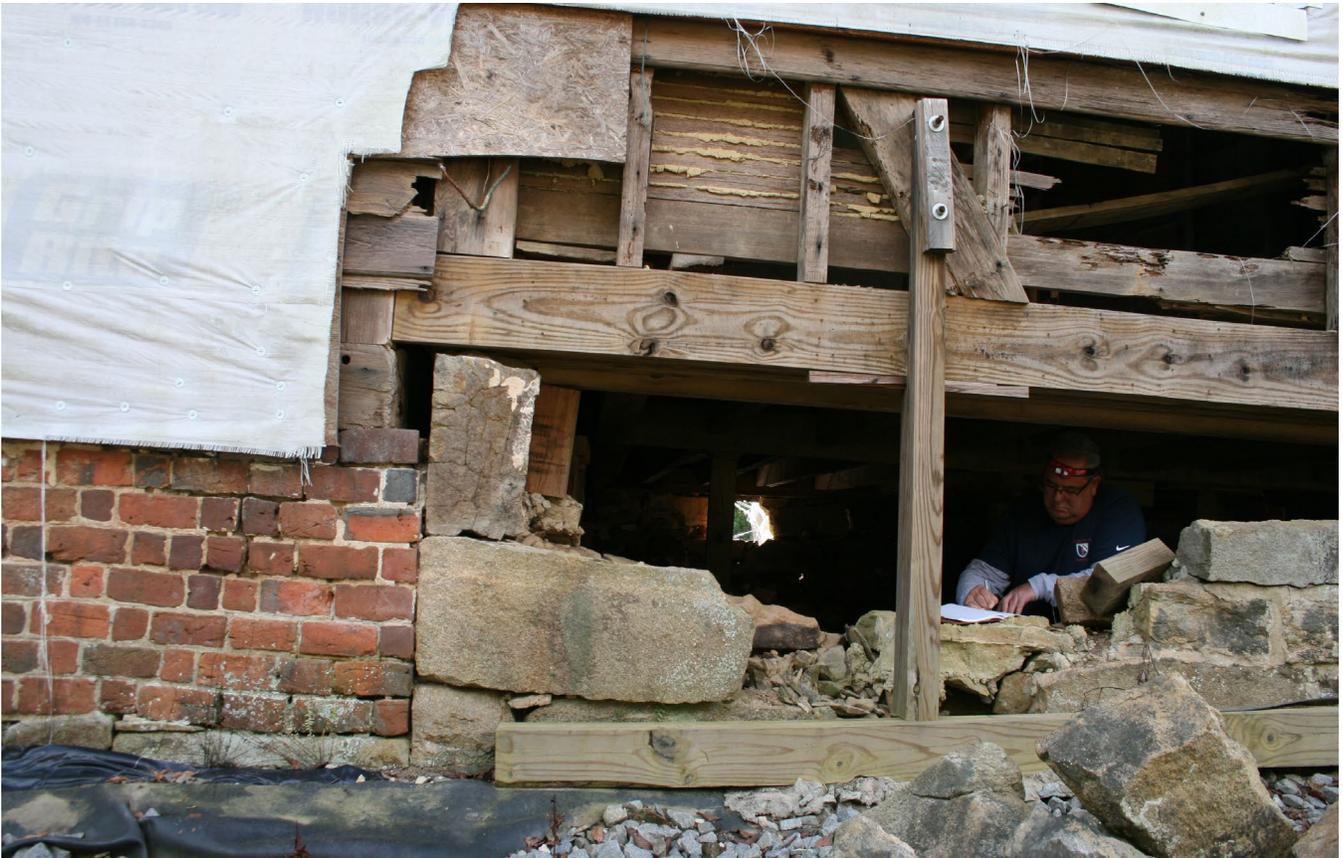
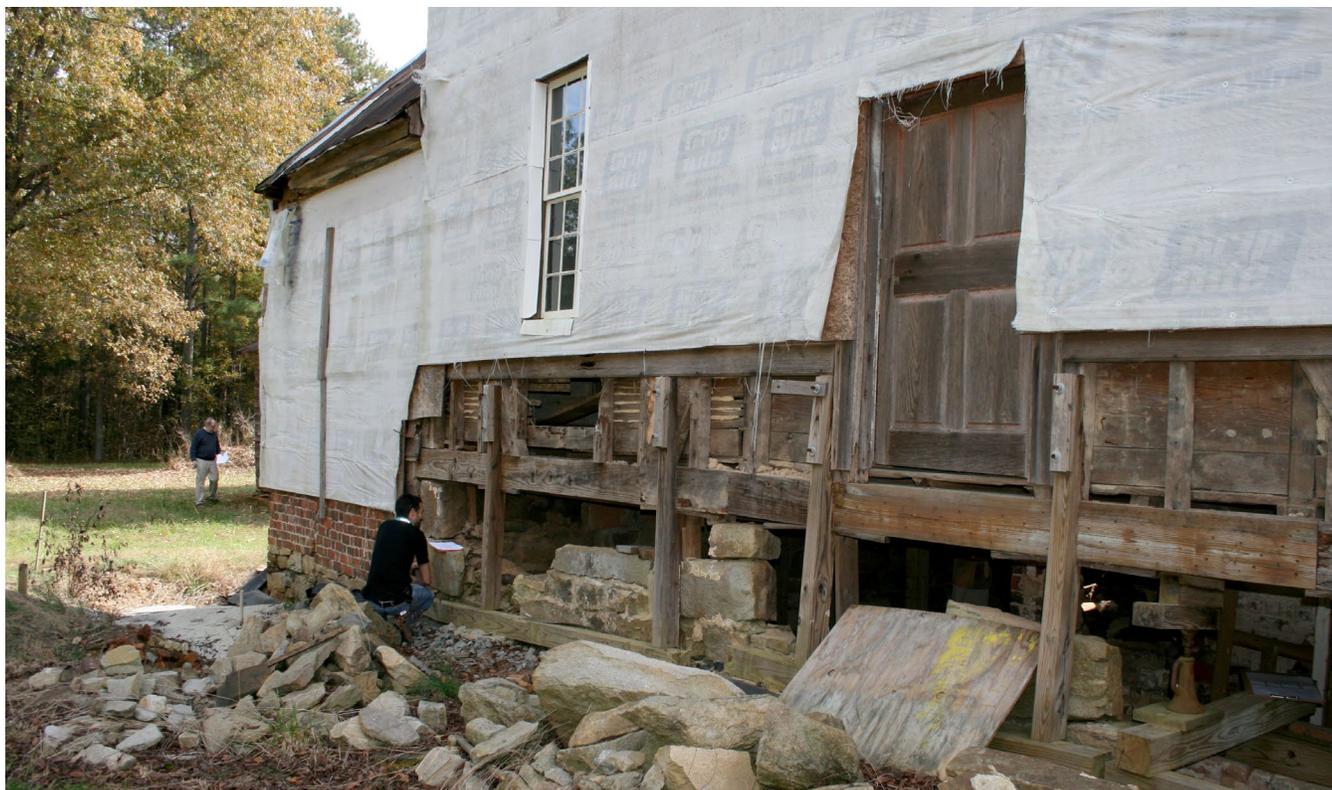
North elevation looking southeast (above) and shoulders and diaper ornament, west chimney (below), 2021.

This chimney might not be standing but for the support provided by the house framing. The stone foundation below grade has been pushed in from west to east (exterior to interior) by hydrostatic pressure from the ground outside and the stone base within the crawlspace has deteriorated to the point of exposing the stone rubble piled within the base of the chimney. The inward movement at the bottom of the stone base has created an outward bulge above grade where the brick masonry begins on the chimney exterior.

It also appears that the west face of the chimney has settled which has exacerbated the bulging of the masonry and caused the masonry on the sides of the chimney to run out of level sloping away from the house. There appear to have been some repairs done at the base of the chimney which might make it difficult to support the structure without opening the chimney where necessary to assess how the interior wythes of brick are bonded into the outer wythes.

The upper part of the chimney needs to be removed and rebuilt. The upper part should be removed prior to the underpinning so that the overall weight of the chimney can be reduced prior to starting that process. If the condition of the chimney requires it to be dismantled, the “diapering” pattern in the chimney breast should be carefully documented and all of the brick pieces should be numbered and saved for reuse during the rebuild. All loose brick at the shoulders should be removed for safety reasons and salvaged for reuse.

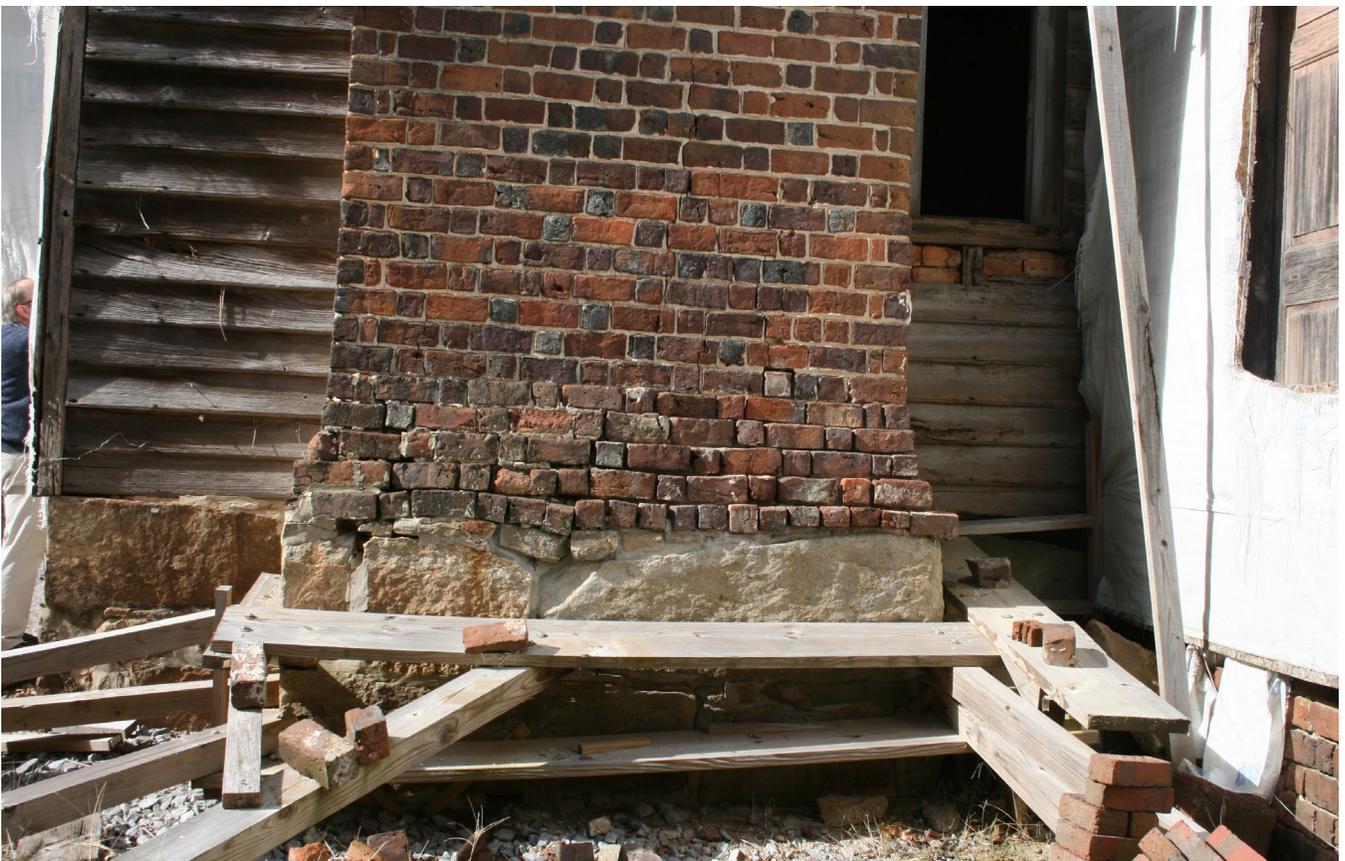
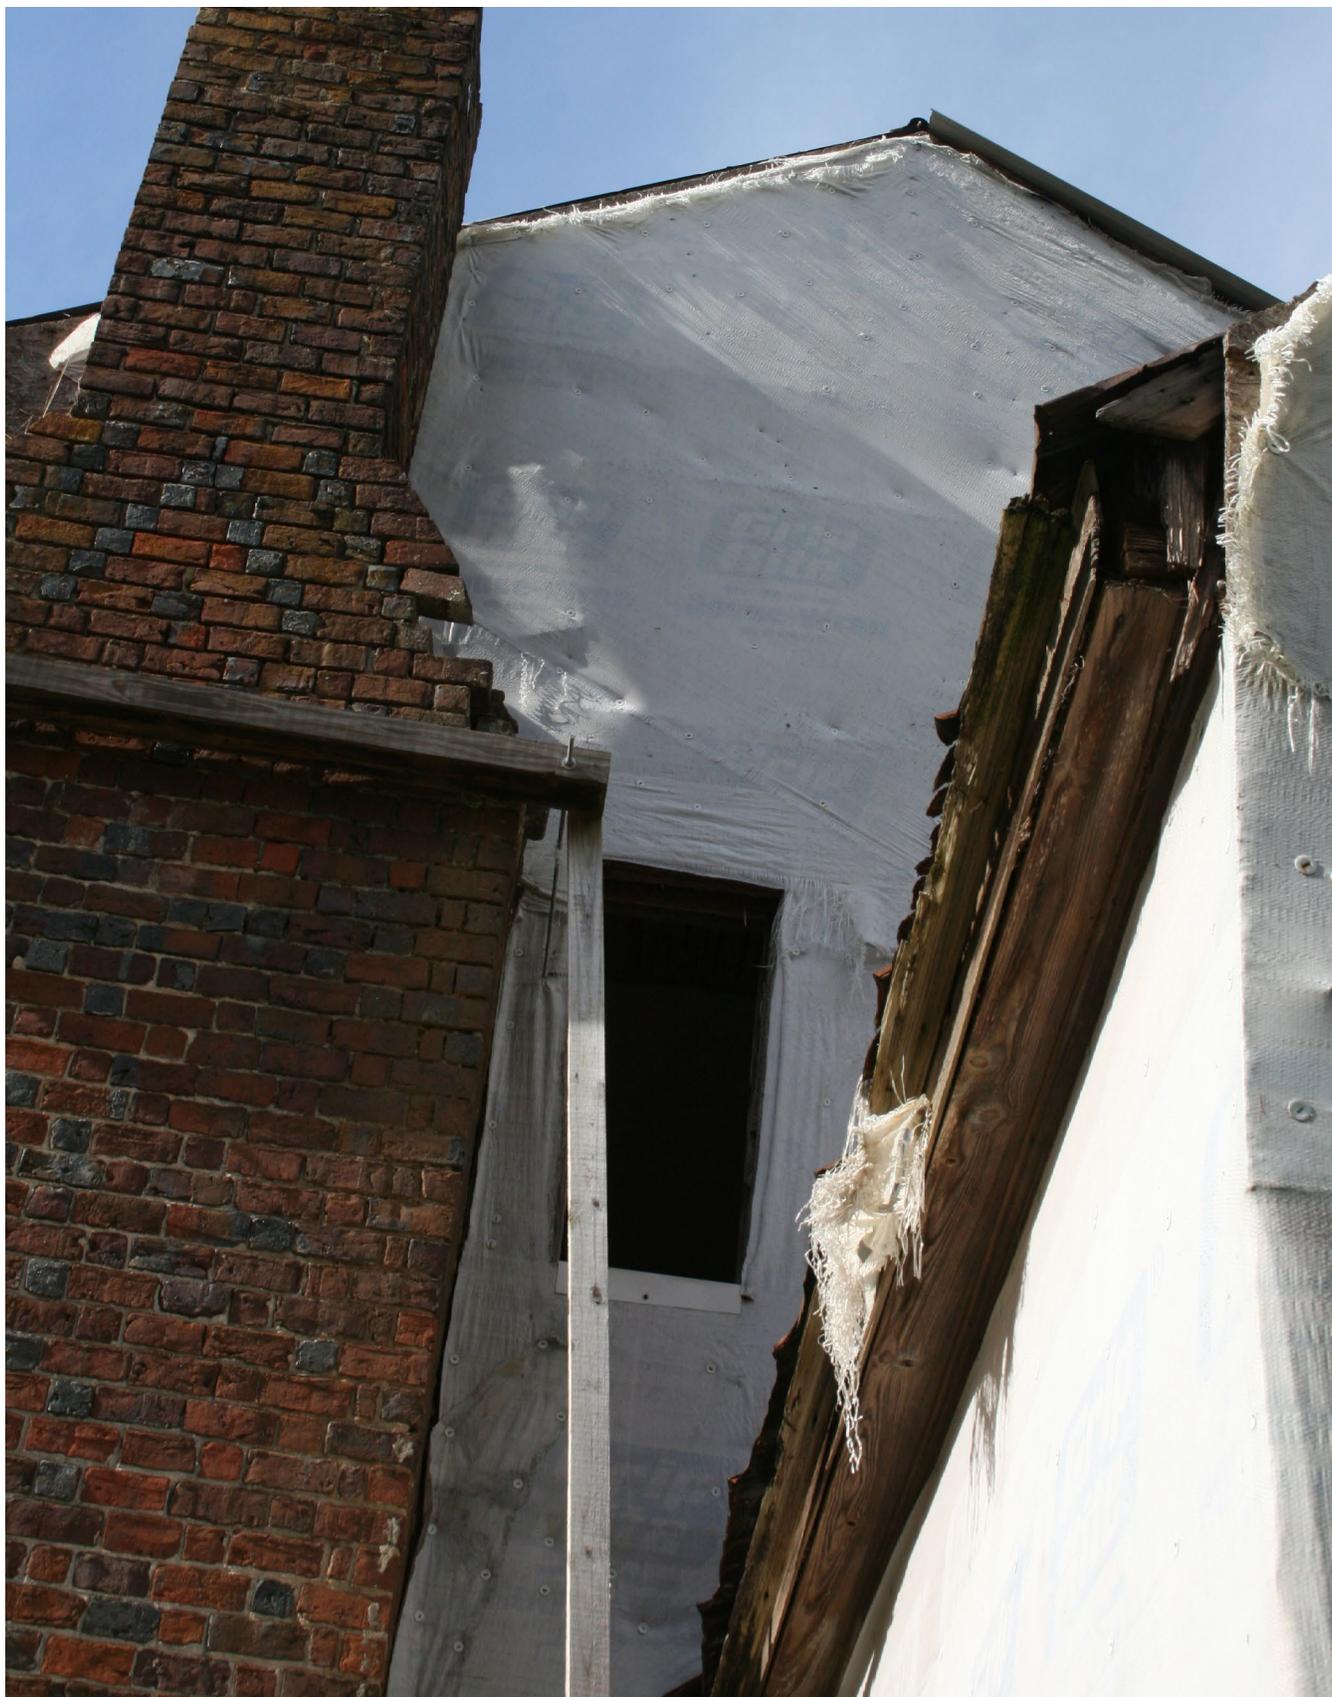
East Chimney looking south at shoulder level showing damage (above) and east chimney base looking east (below), 2021.

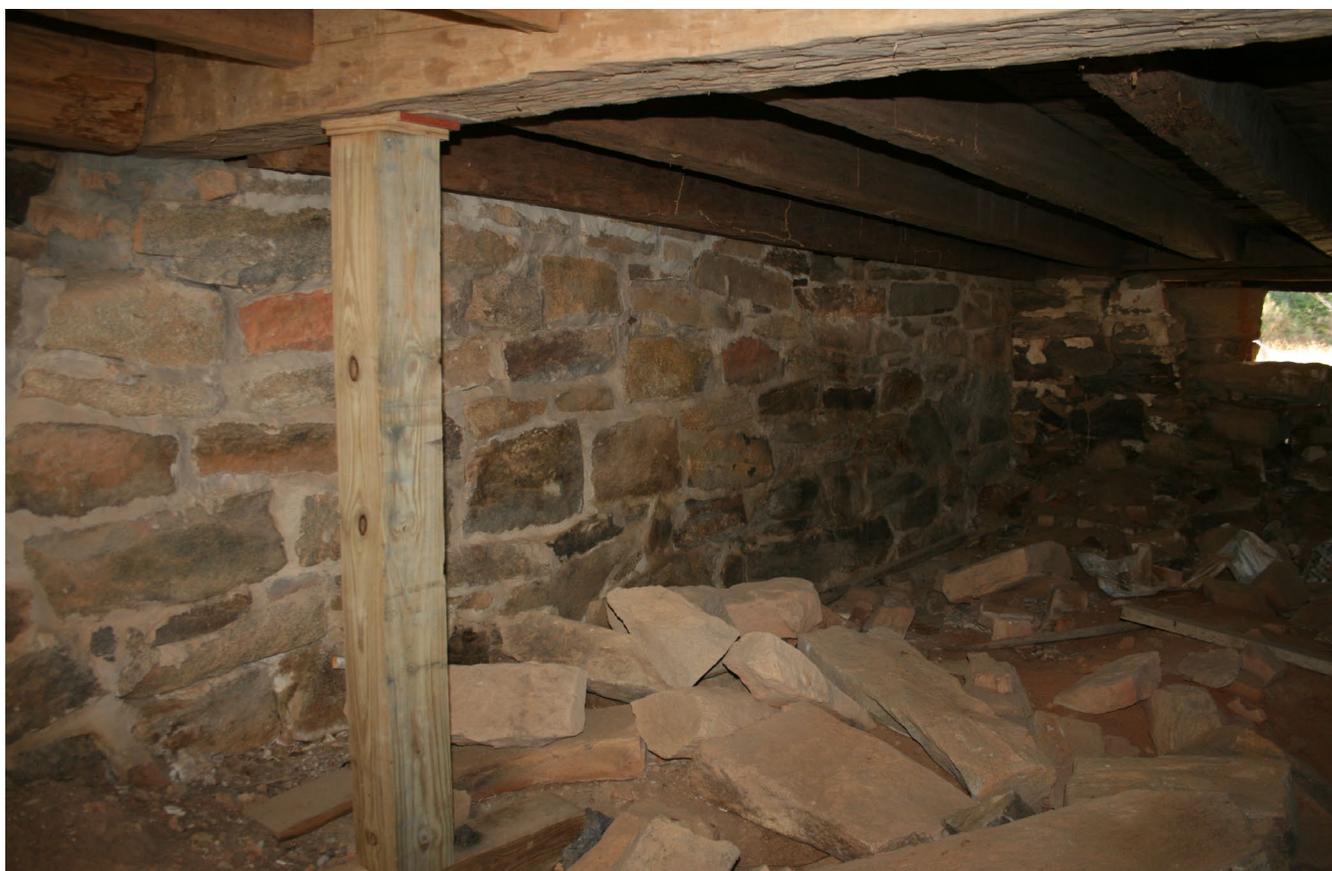
Basement, original stone pier looking southwest (above) and eastern room looking southeast at rebuilt stone wall (below), 2021.

This original section of stone wall is a good indicator of how the rest of the wall was originally built and why it was doomed to have problems from the beginning. Although the foundation wall may be 18”-24” deep in some places, the beam/plate that supports the frame of the house is only 10” deep. This means that the weight of the entire house is concentrated on only 10” of stone wall that is balancing on rubble and chinking. These stone wedges do not provide the interlocking bond that larger pieces do when they overlap each other.

When the foundation wall is rebuilt, it is important that any attempt to replicate the appearance of the foundation stone as seen in this one section of original foundation should implement a method of stone assembly that maintains the appearance style while also giving the wall more structural overlap.

We recommend that the available stone on site is used in combination with suitable brick to build an interlocking stone and brick wall with stainless steel helical tie rods placed at regular intervals to provide support between the stone veneer on the exterior and the masonry within the crawlspace. The veneer would be built to replicate the original masonry as described above but the stones will be woven to backup masonry comprised of brick and stone as needed. The use of brick will provide units of masonry small enough to adapt to the irregular stone shapes but large enough to overlap and provide structural overlap within the masonry wall. The walls should be built using a lime mortar to provide for consistent evaporation of water within the wall and to promote the self-healing of micro-cracks that may develop with the uneven pressures of the stone assembly.
