DROMGOOLE HOUSE HISTORIC STRUCTURE REPORT

Old Brunswick Circuit Foundation
Valentines, Virginia

Report by Glavé & Holmes Architecture

March 25, 2022

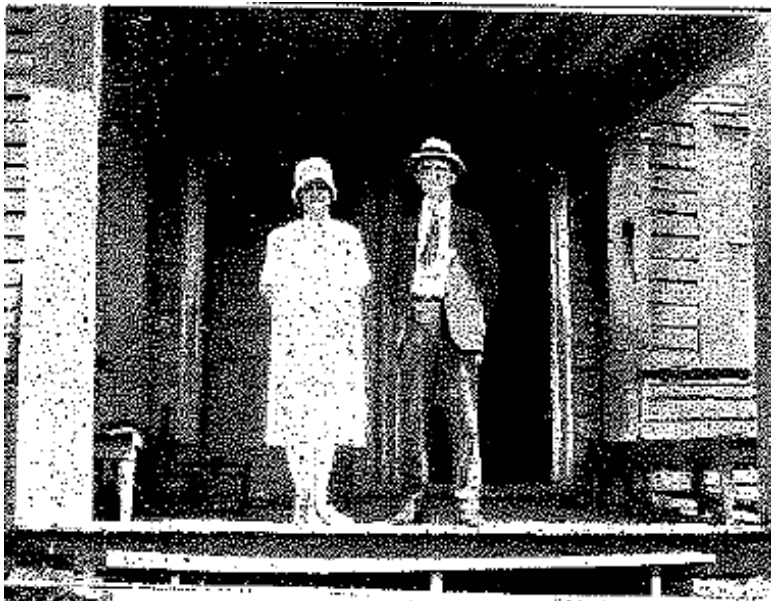
This historic photograph from 1929 shows the porch with protective placement of two side benches to prevent people from falling off the sides of the porch.

The porch needs a great deal of repair to make it safe for use by visitors. The foundation is fragmentary, the flooring is loose and unreliable, and the stairs are not usable by visitors. There are no porch railings, which is a hazard, even though the project probably doesn't need to meet code as an existing historic building. The historic photograph from 1929 on page 21 shows the porch with protective placement of two side benches to prevent people from falling off the sides of the porch.

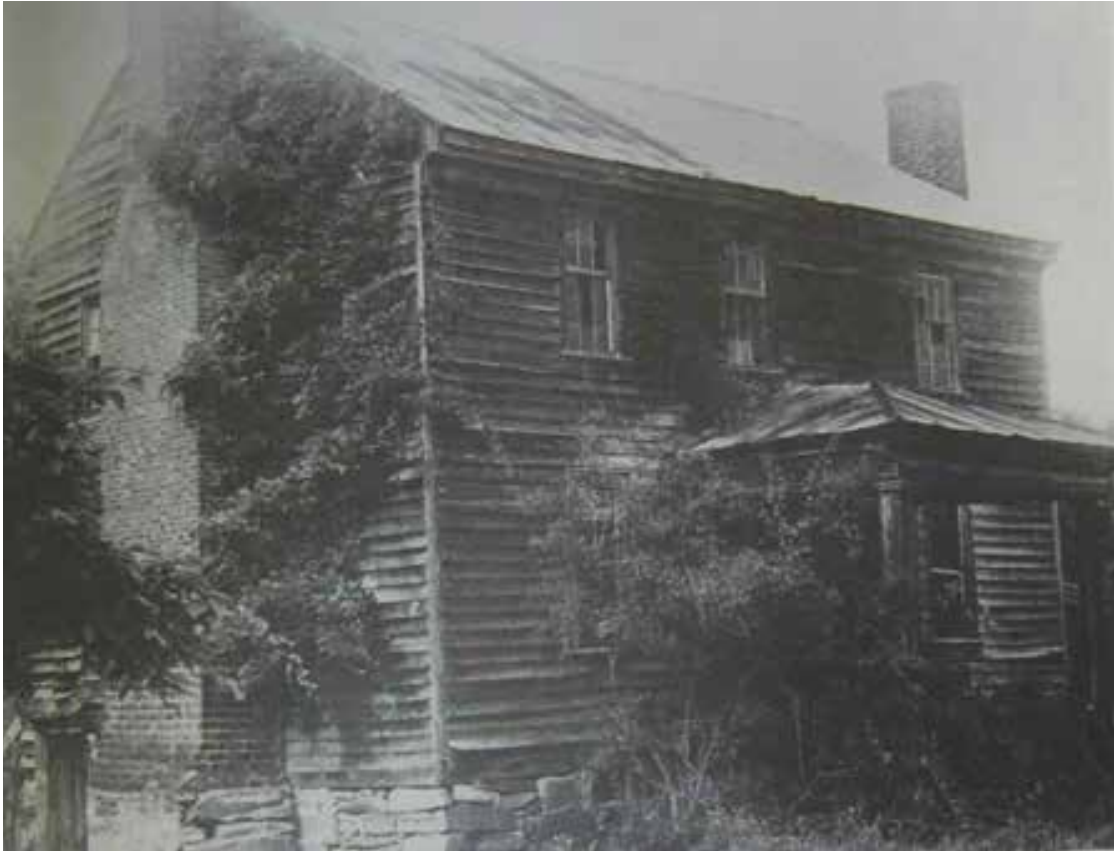
Southwest corner from the southwest showing repaired foundation, 1970s [Corker, Collection Old Brunswick Circuit Foundation].

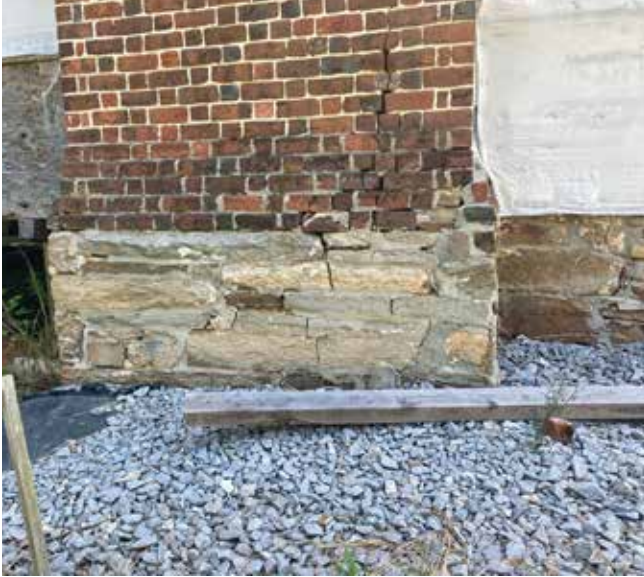
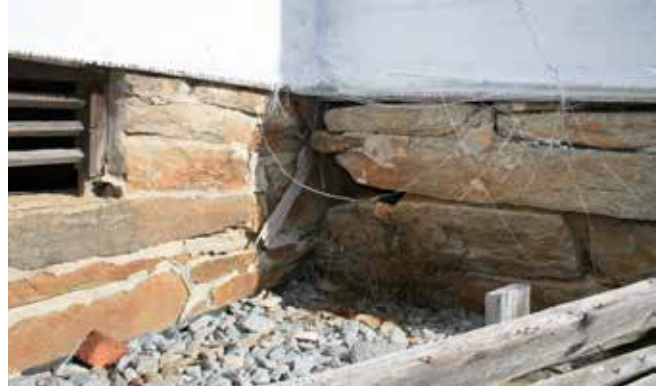
Dromgoole House, west chimney base (left) and western angle of front porch (right).

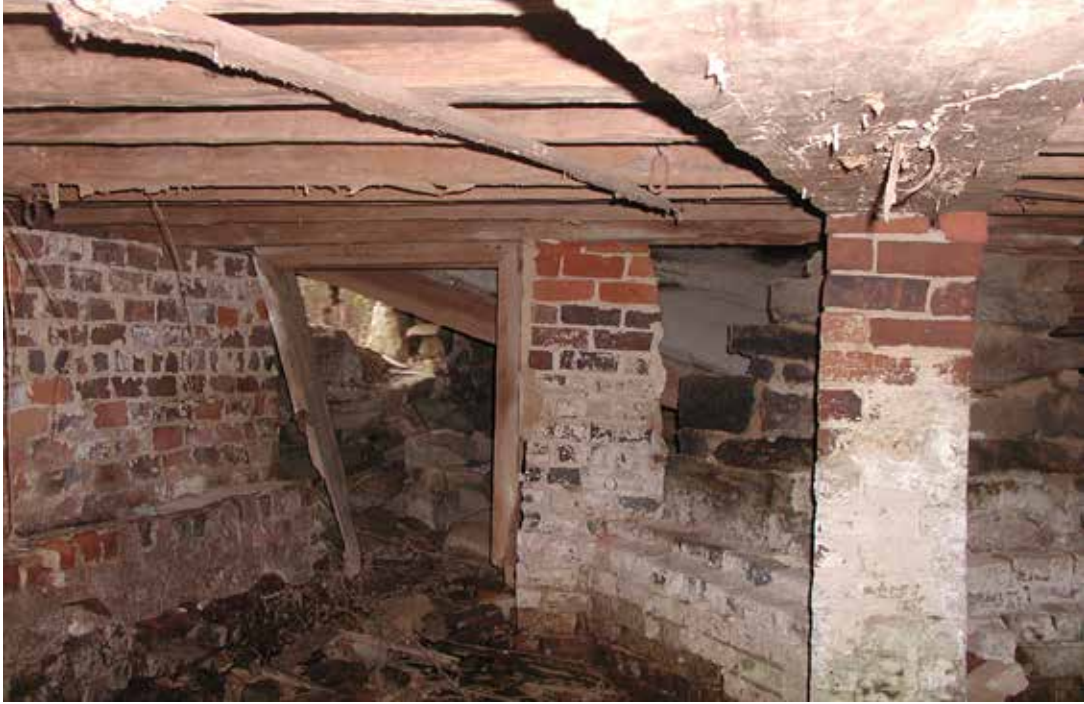
The foundation is in very poor condition. At some point after the crawl space floor was lowered, the exterior foundation wall, which was made up of an inner and outer layer separated by a rubble or mud-filled core, began to fail and was rebuilt, probably in phases over many years, as an uncoursed veneer reusing the original stones. A photograph from 1960s (page 29) shows a missing section of stone at the southwest corner before it was repaired. The only original section of properly coursed stone survives under the front porch. The rest of the foundation appears to have been rebuilt over several years using original materials. The inner layer of the foundation also failed. The inner layer of stone at the east end was rebuilt in the twentieth century, and most of the rest of the inner layer and about half of the outer layer has fallen. Thanks to local experts, the building has been shored up and the east chimney partially stabilized. The west chimney exhibits serious cracking and evidence of bulging subsidence, indicating a pressing need for stabilization and repair. The interior foundation wall at the west chimney has entirely collapsed. The building has very little lateral system at the base especially on the north side and its gravity supports are patched together. Foundation repairs should move ahead as soon as possible to minimize risk of losing the building or a more thorough and professional shoring system should be put in place.

Basement- view of the north half of the Basement looking east showing the diagonal pier and added brick partition to the right. The door frame, no longer in place after the repairs of 2013, connected the room on the east side of the Basement with the room(s) on the west.

- Provide a crawl space entry to the north side of the west chimney. Recreate the likely form of a historic basement bulkhead at that location.
- The section of brick cross wall on the interior should be preserved in place and the Basement filled with gravel to the level of the original crawl space.

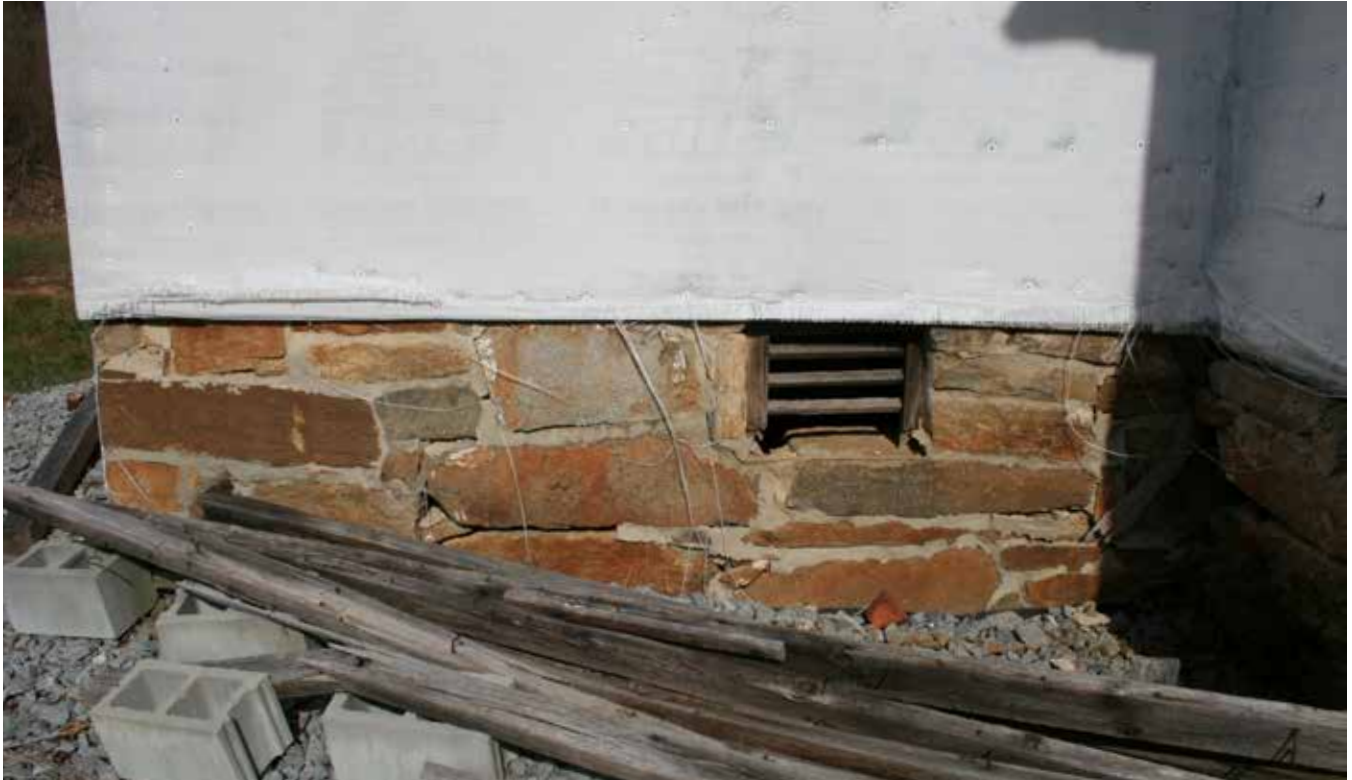
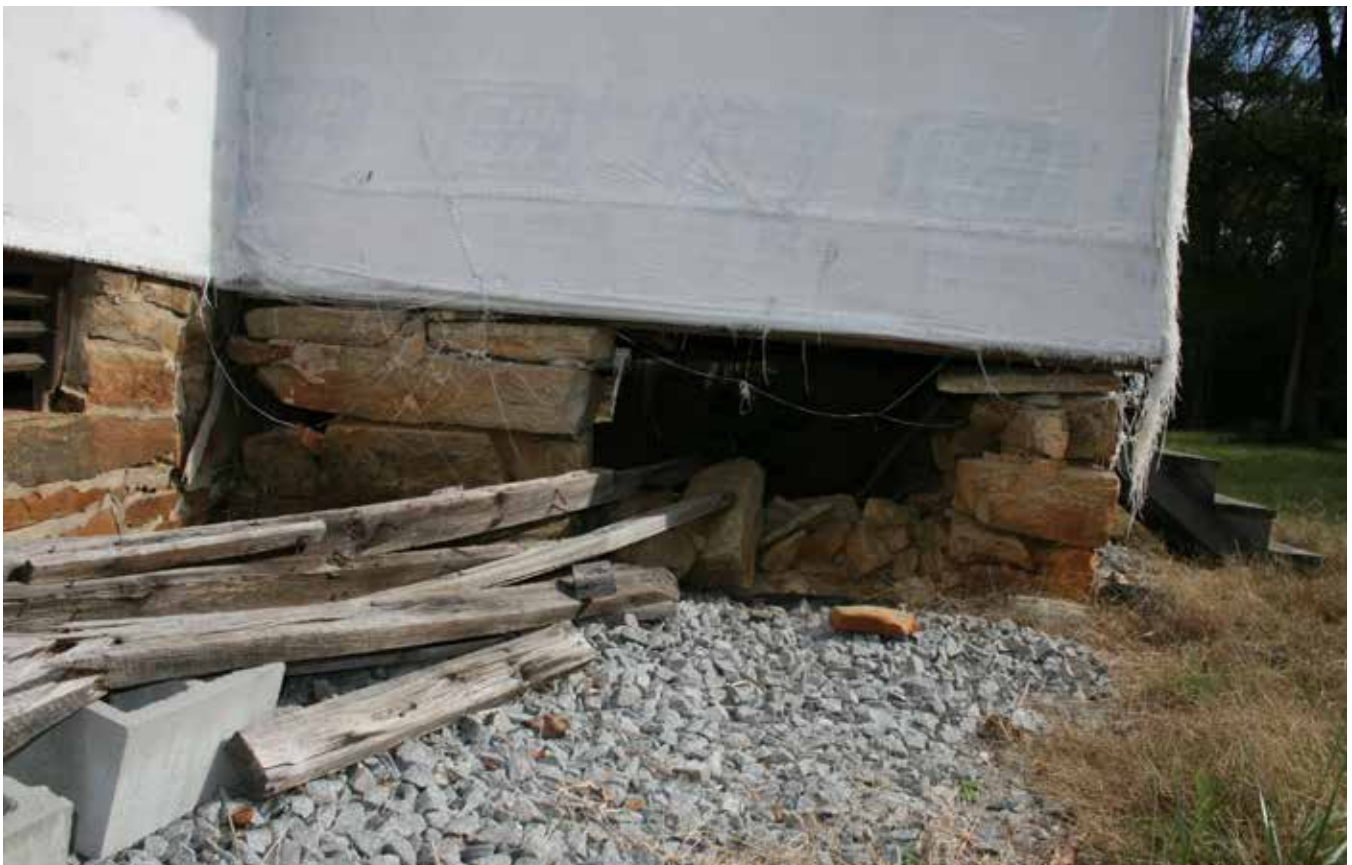
Foundation, west end, south elevation (above) and west end of porch (below), 2021.

- Remove and rebuild the entire foundation, except for intact portions of the south porch foundation and the central section of the south wall under the south porch, which appear to be structurally competent.

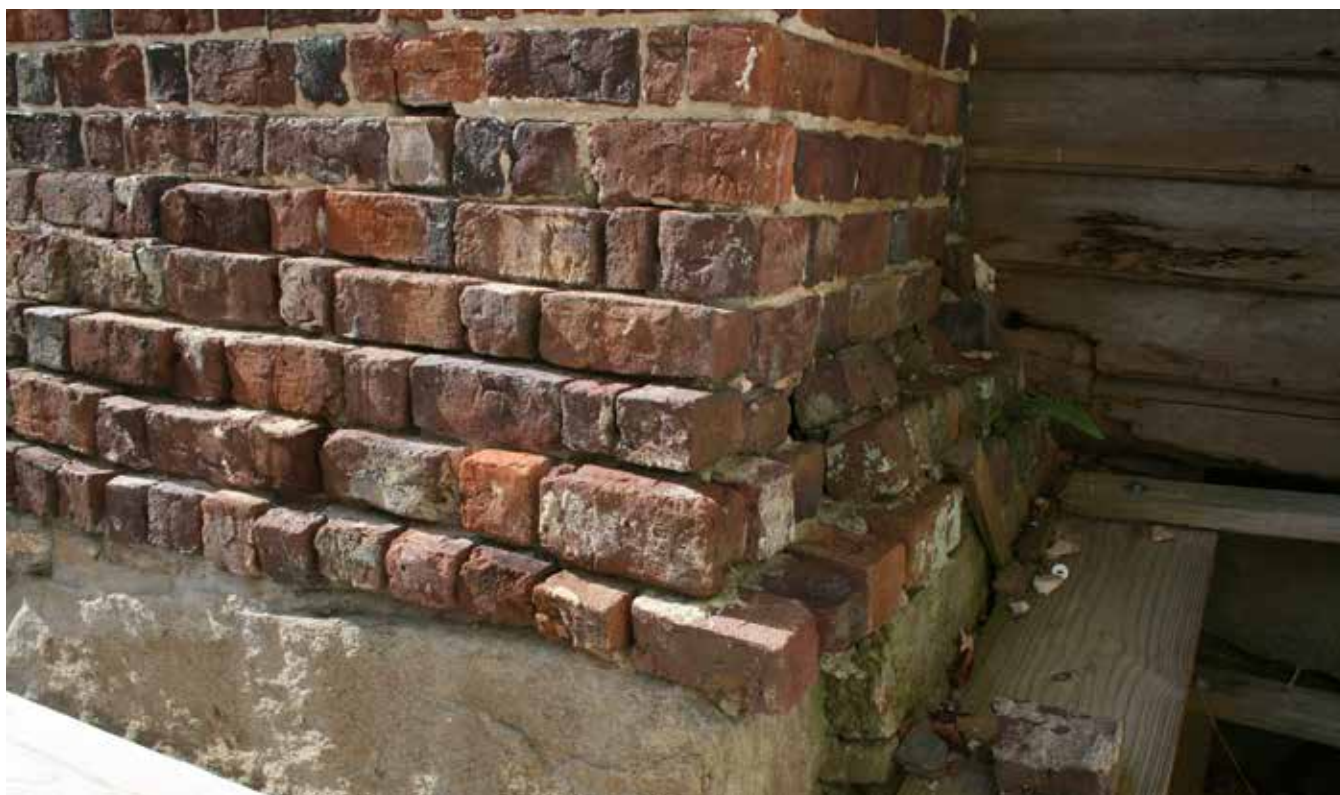
The chimney at the east end was moving and collapsing at the base, as the outer layer of stone was forced to carry most of the weight of the brick chimney shaft above. Tom King repaired the base of the chimney and filled the void at the interior with concrete grout. The west chimney has similar problems that have not been addressed. Cracking and bulging at the base indicate that the stone outer face does not have capacity to carry the weight of the brick above. At both chimneys, the tile that originally shed water is missing from the shoulders and the upper shaft has lost integrity.

Base of east chimney (above) and East Wing foundation from the southeast (below), 2021.

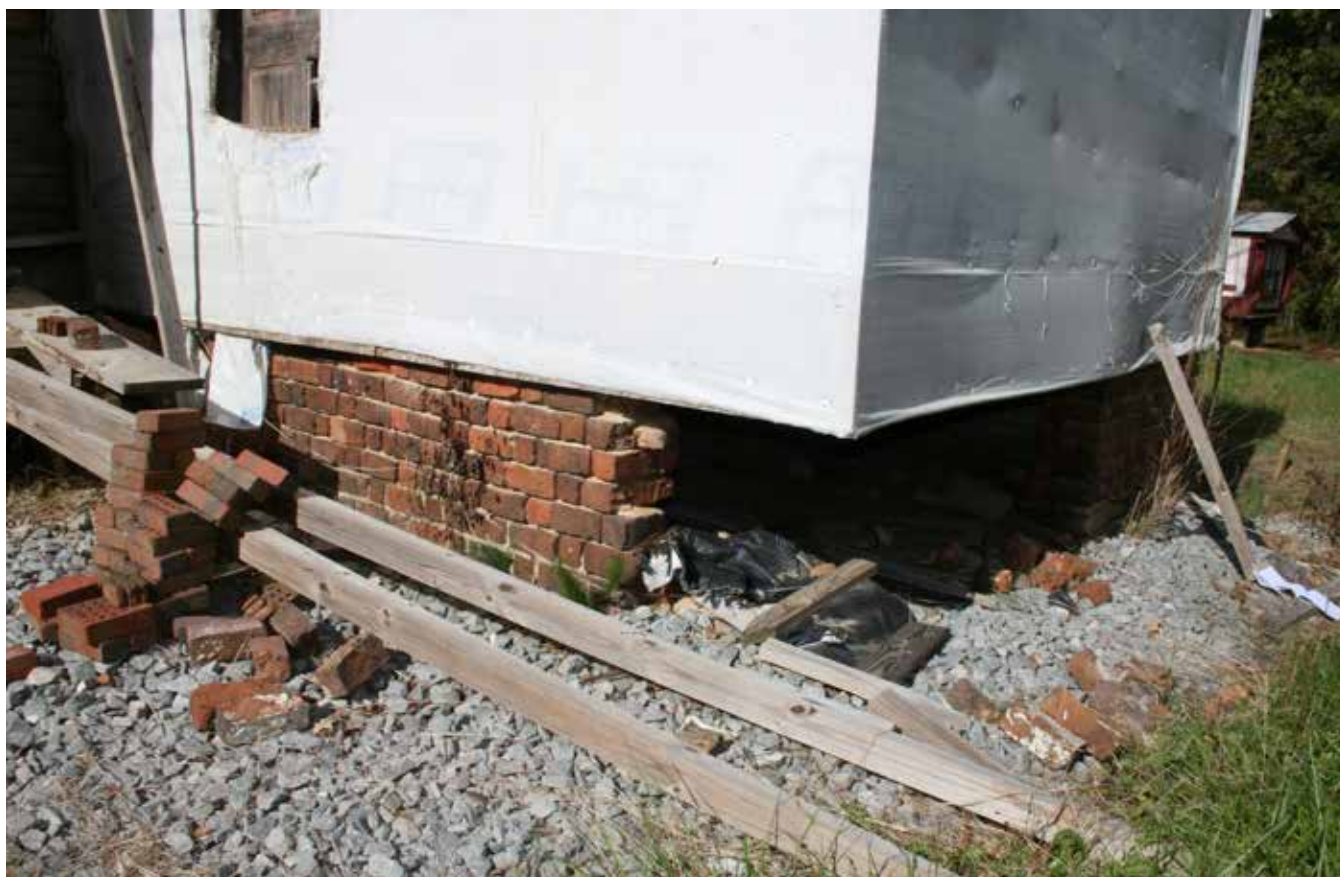
The exterior of the wing is in poor condition. Some of the weatherboards and trim elements are possibly reusable in place, particularly on the south, where they were protected for many years by the porch. The window sashes are missing. The floor framing is partially collapsed and the floor damaged. The north foundation wall is intact, although damaged by cracking. The east end and south foundation walls are in poor condition or missing entirely. The roof is sheathed with an unusual 2-V surface-nailed metal roof.

- The foundation, exterior trim, and weatherboard should be repaired or reproduced to restore the exterior to its c1810 appearance.
- Significant wood framing repairs / replacement required. Access should be closed until the flooring is sound. The floor structure should be repaired as recommended by structural engineer.

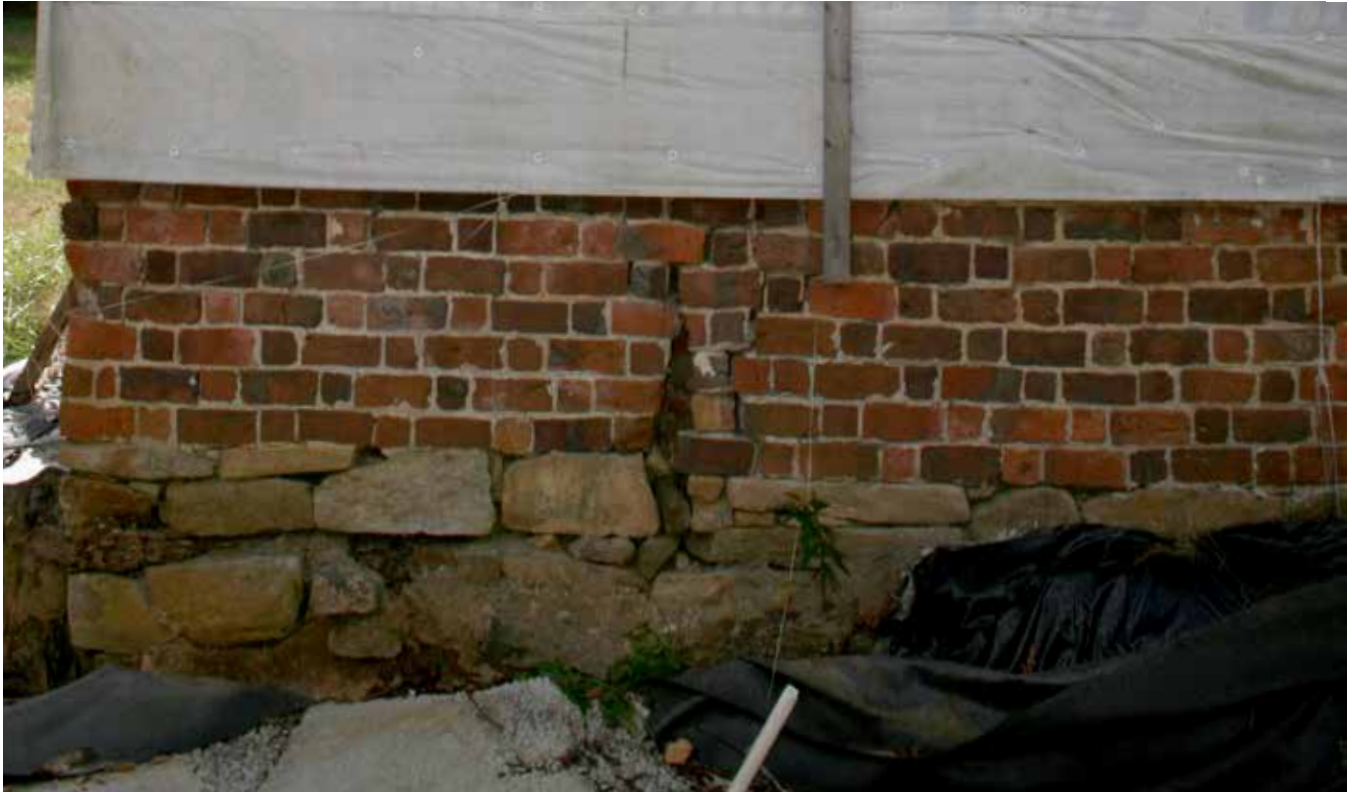
Foundation, north elevation, East Wing (above) and junction between East wing and main house foundation (below), 2021.

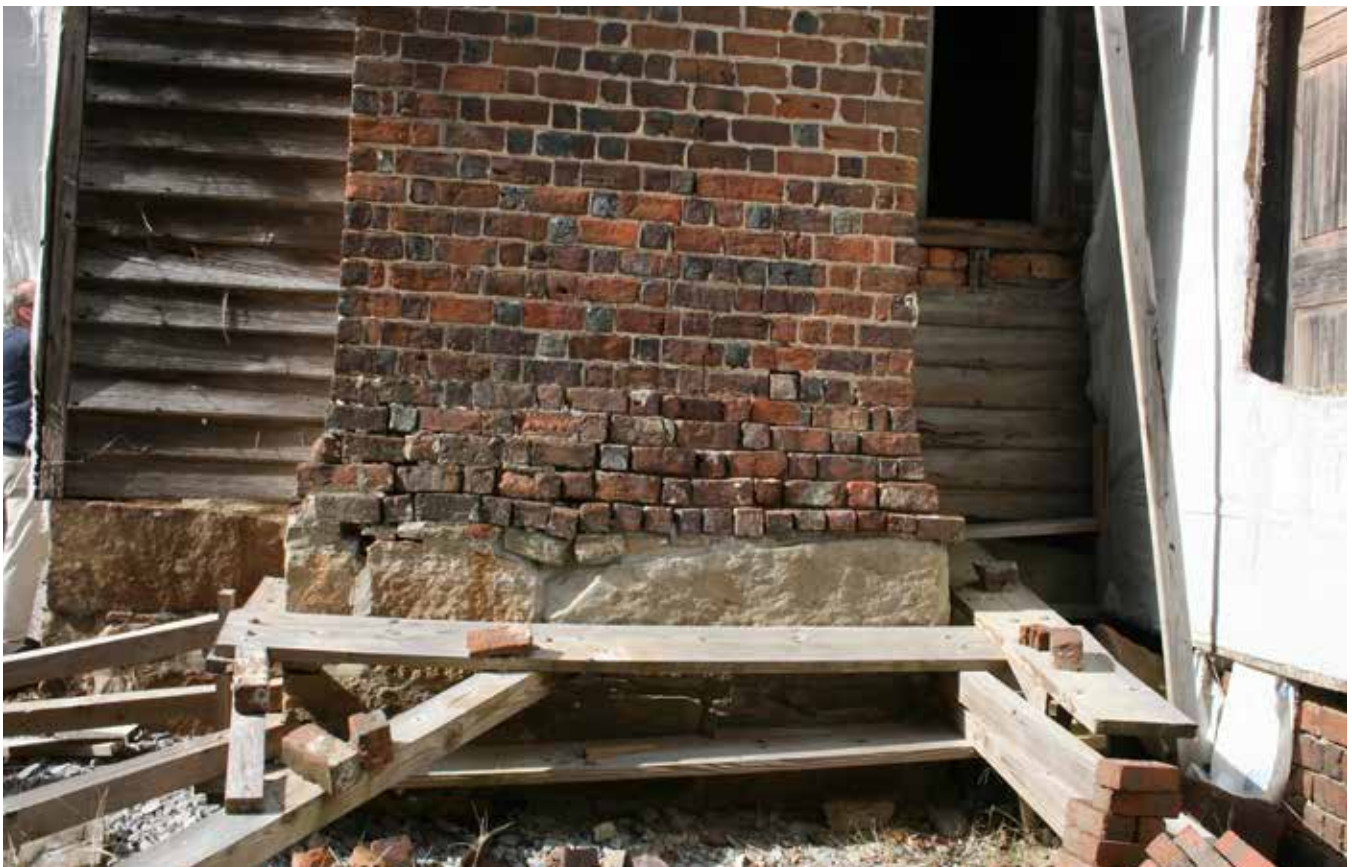
East Chimney looking south at shoulder level showing damage (above) and east chimney base looking east (below), 2021.

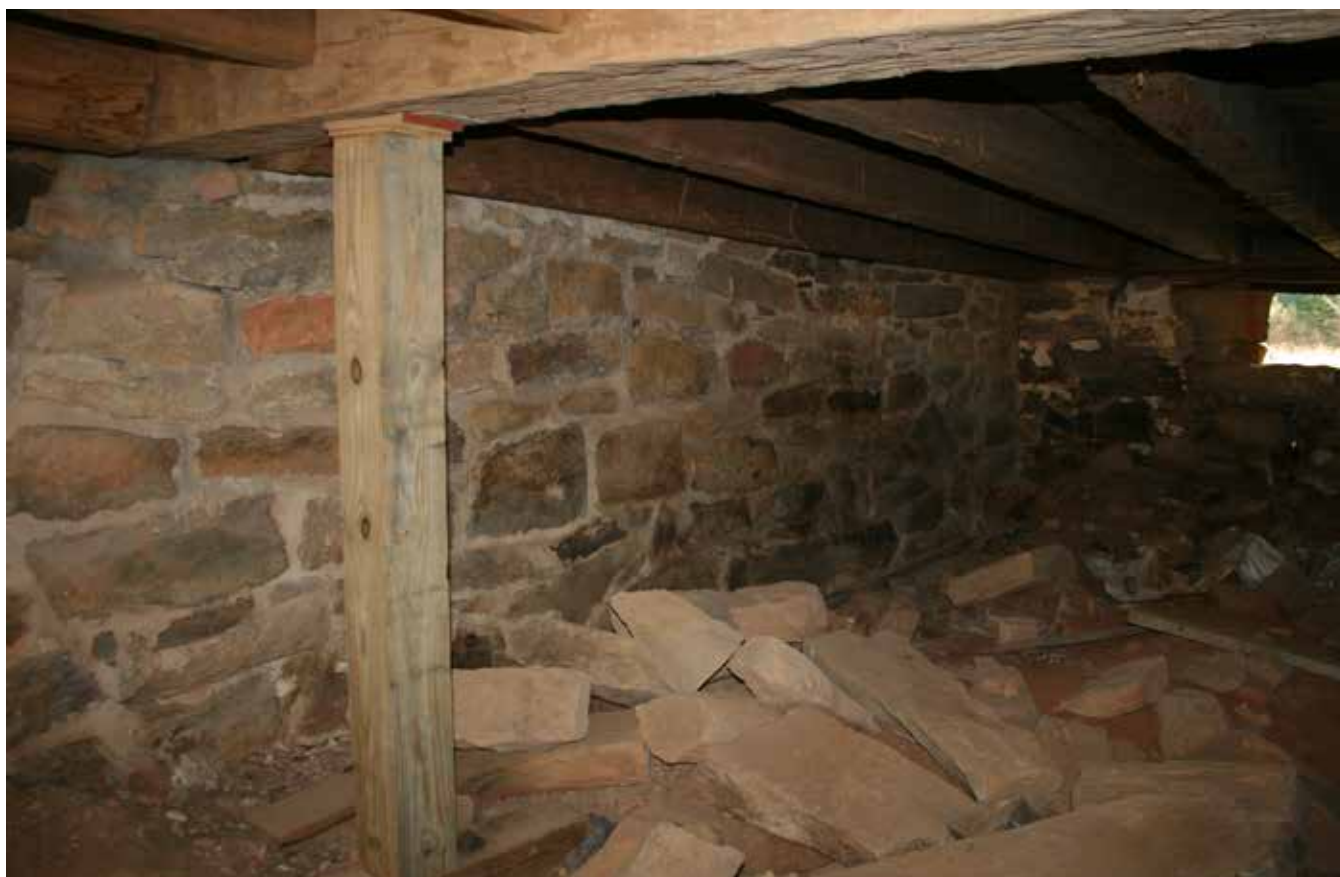
Basement, original stone pier looking southwest (above) and eastern room looking southeast at rebuilt stone wall (below), 2021.

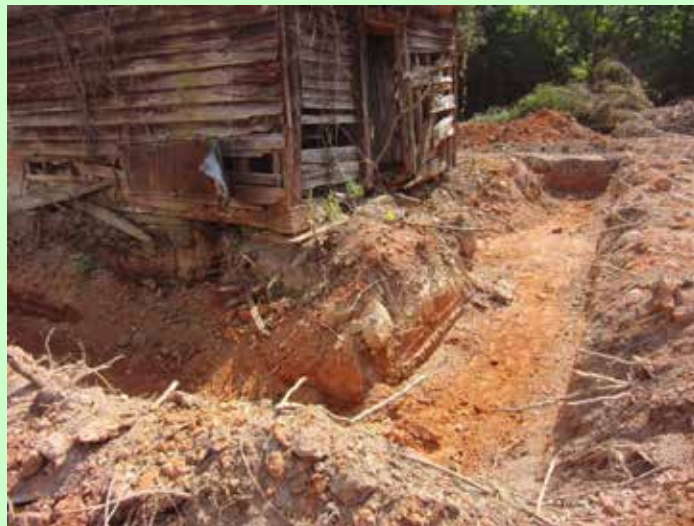
The Trench Around the Spinning House

"There is no drain field. It drains out to daylight at the bottom of the hill near the woods line. There is a minimum of 8" of no. 3 stone on top of the Voltex DS sheets, and 60 mil Firestone pond liner. It's described in detail on my website page about basement waterproofing."

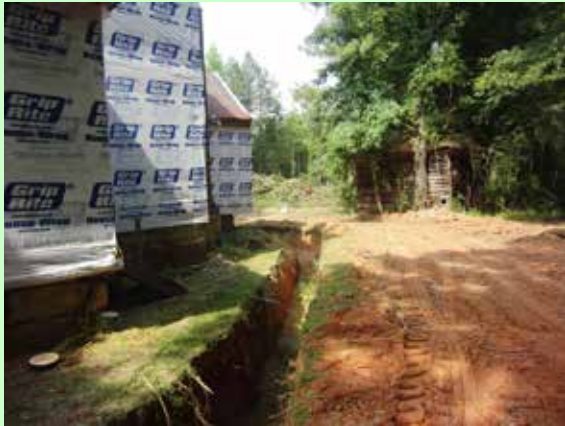
PHOTO A

Bottom of trenches were first dug with a 12" wide bucket on the mini excavator with which Tom King dug a grade establishing ditch. The large excavator was not to disturb this part and saved much time with the more expensive equipment later

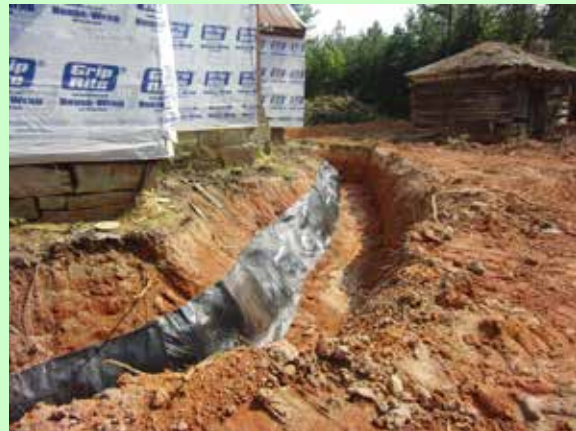
PHOTO B

First layer of the Voltex DS sheets

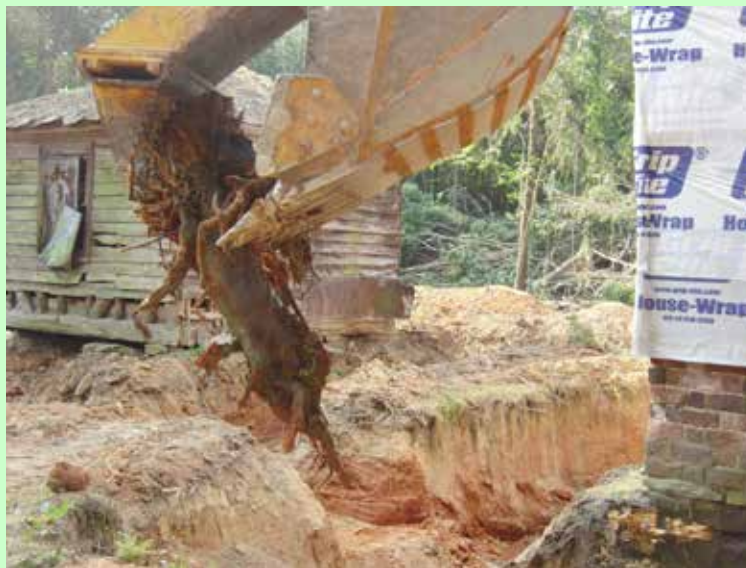
**"This shows how the trench around the Spinning House was tied in with the house drainage system.
It also shows one of the stumps taken out from trees that had grown up against the back of the
house. There were three such 10" diameter pine stumps against the foundation along the back of
the house. "**

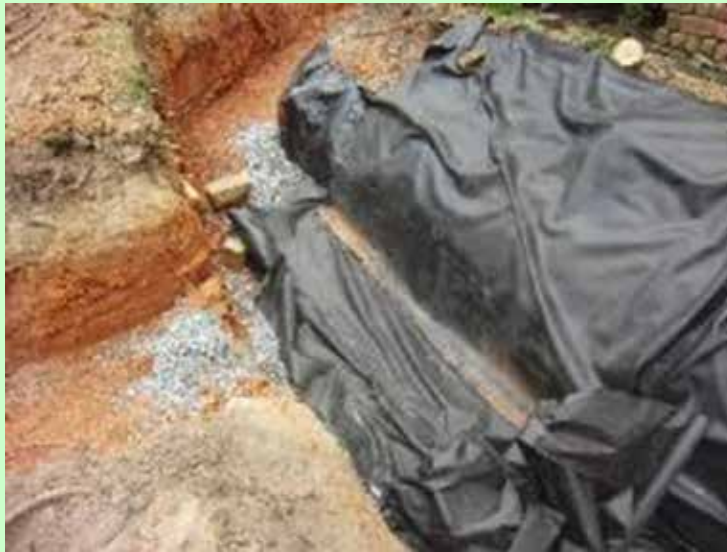
"I believe there are pictures all around from the grade establishing ditch to the geotextile fabric being installed, to backfilling. This photo shows the Voltex DS and pond liner only covering the slopes with the geotextile fabric covering the no. 88 stone. The drainage pipe went on top of this bottom layer of geotextile fabric and all the no.3 stone was also covered with geotex. "

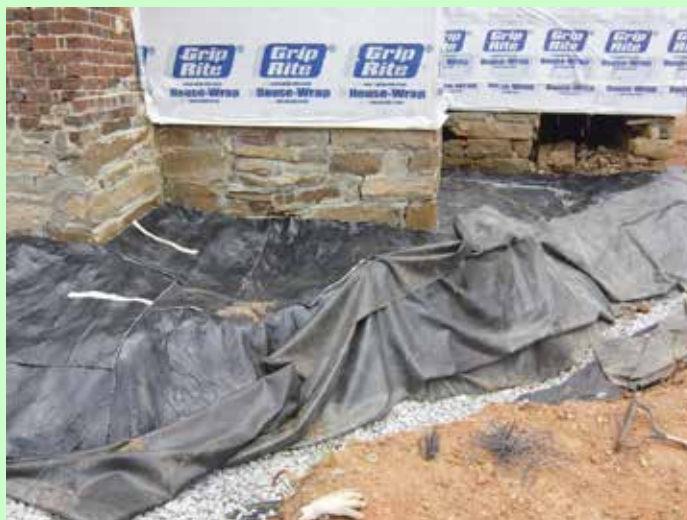
"This is the pond liner over the Voltex DS sheets, before the no. 3 stone. If you look closely, you can see there are two different kinds of membrane. The smoother looking layer that goes right up to the foundation is the Voltex DS. The other layer that is not smoothed out yet is the pond liner in preparation for covering the Voltex DS. I never made any drawings. The grade establishing ditch started 5' deep on the northeast end, and went down a minimum of 1 inches in 8 Feet. "

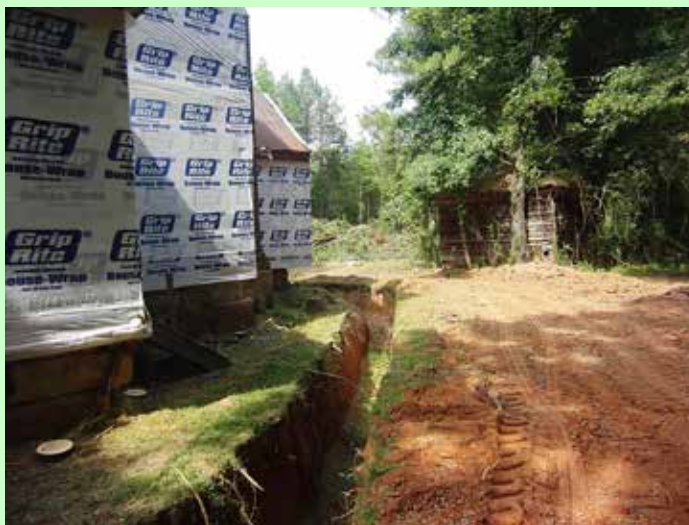
Bottom of trenches were first dug with a 12" wide bucket on a mini excavator with which Tom King dug a grade establishing ditch.

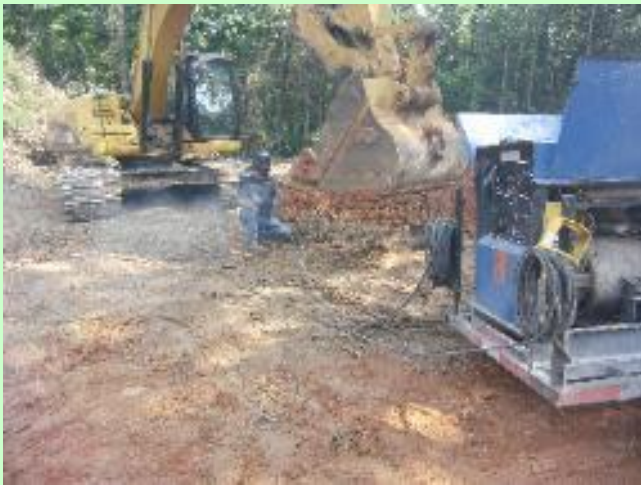
Welding bucket edge

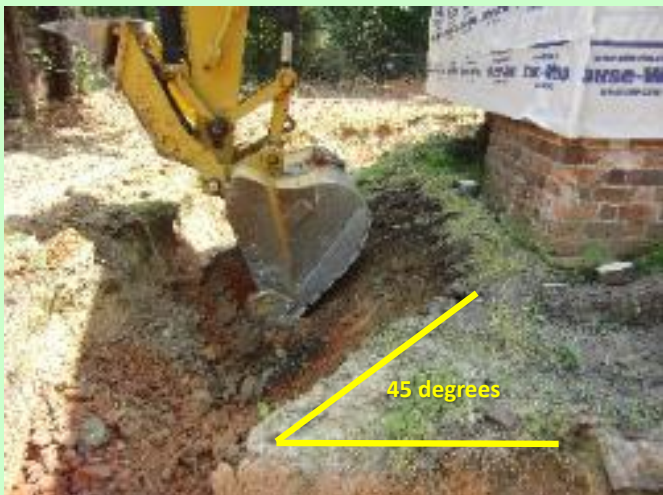
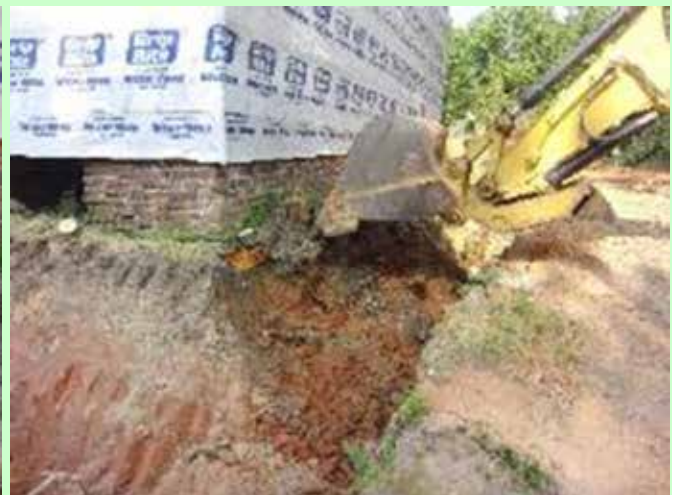
The large excavator creates the slope from the foundation

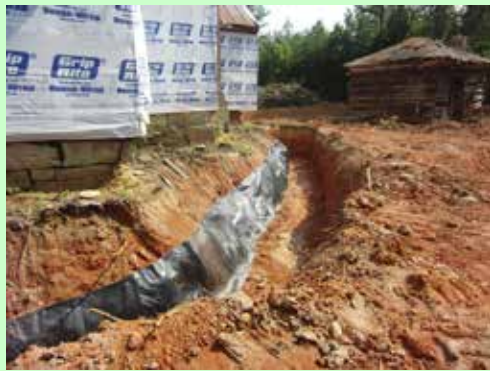
Above: Voltex DS – comes in 3 X 7 sheets. Every sheet gets overlapped by the next one.

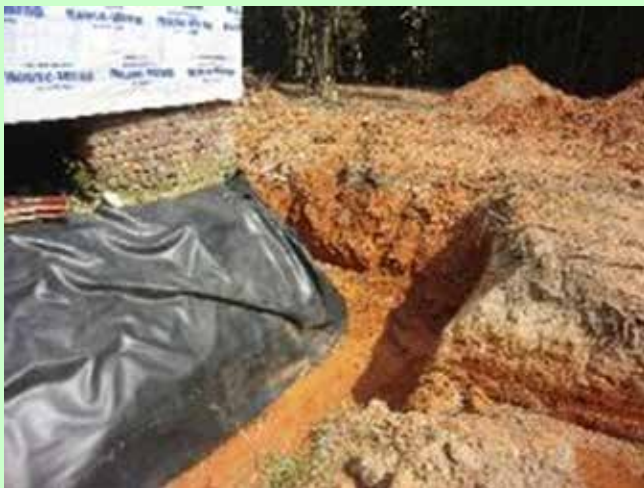
Pond liner – the trench out to the lower right in this photo is the one connecting to the Spinning House trench.

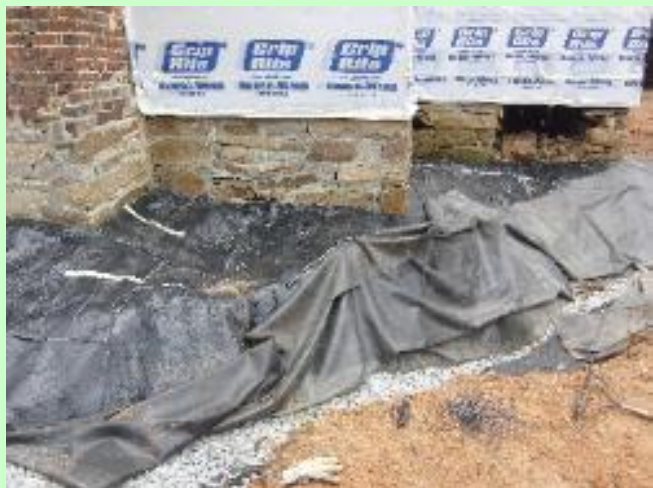
Voltex DS before the no. 3 stone with the pond liner not placed completely over it yet. The pond liner does not have a shiny surface, but the Voltex DS top layer is shiny.

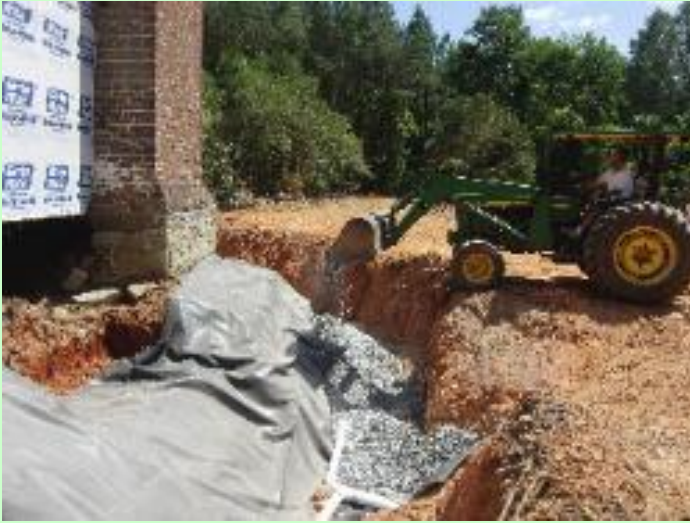
Top no. 3 Stone covering the pipe which drains down the hill starting on the northwest corner of the house.

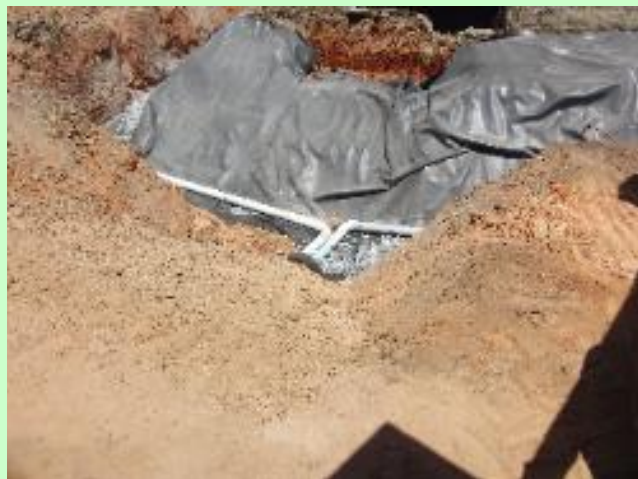
Drainage pipes with holes changes to solid pipes when it turns to go down the hill

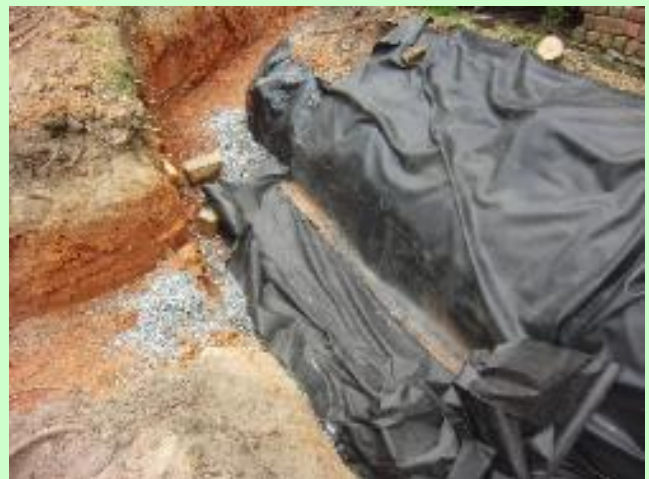
Geotextile Filter fabric at the bottom of the trench, Voltex Ds and Pond Liner on the slopes

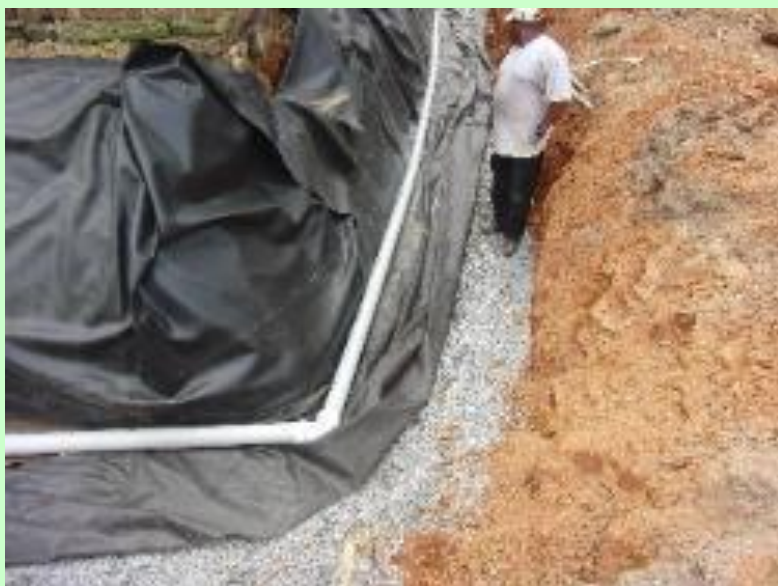
Above: Pipe on Geotextile filter fabric, with Voltex DS and pond Liner on the slope.

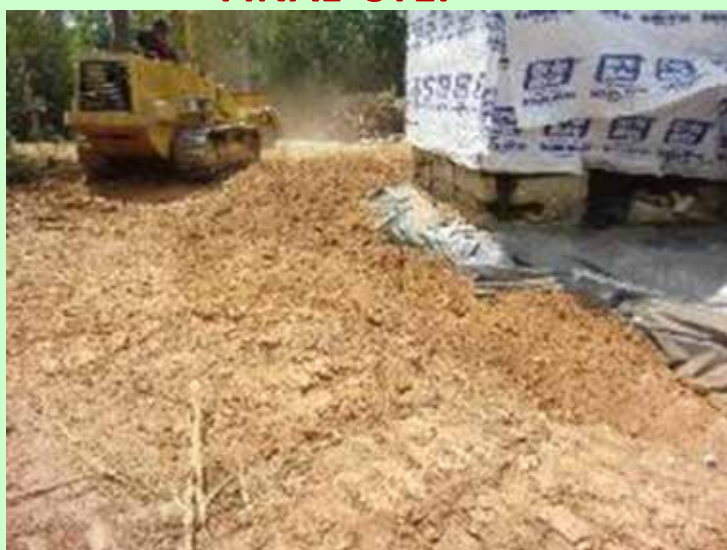
Dirt going on top

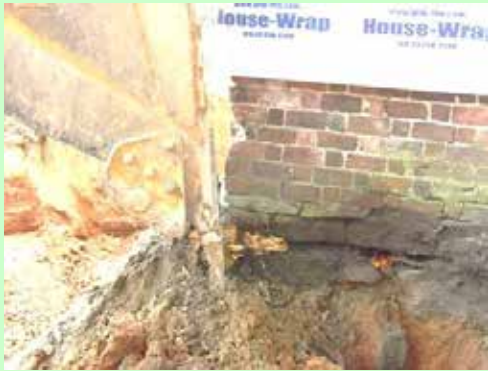
Handling Tree Roots

The concrete you see in the excavation behind the house was leftover from the chimney base filling, and cost nothing, since we would have had to pay for it even if they carried it back, being in the minimum charge. It fills in where the Pine stump roots had been removed 6 years prior. By the time that concrete was put there, those roots had rotted, been removed, and left hollows under the brick foundation for the single room. That concrete had plasticiser in it, so it flowed into all the hollows left by the roots, and also stabilized the dirt under the foundation, taking the place of the radial load zone that was missing because having to get those stumps out.

This picture [above] shows just some of the roots from that one stump that had roots under the single room brick foundation. There were more roots into that stone footing along the same stretch of foundation wall but we don't think any photos were taken of that. About 6 feet to the right of what you see in this picture was a much larger void left by larger roots. The residual roots were there in 2011 but by 2017 they had rotted, and were removed, leaving holes. Those are the holes I'm talking about the concrete filling. We picked out the remnants of the rotted roots, and blew the voids out with compressed air before the concrete pour.

That was the reason I left the part of the excavation for the waterproofing system open back there where that stump was to start with. I knew we would have some leftover concrete at some point. It would have damaged something to pull those intact roots out, but I knew they would rot in a few years.
